## Introduction

1. This chapter considers the underground electrical system at Pike River. The integrity of parts of that system, and its potential to be a source of ignition for the first explosion, have been the subjects of conflicting evidence.

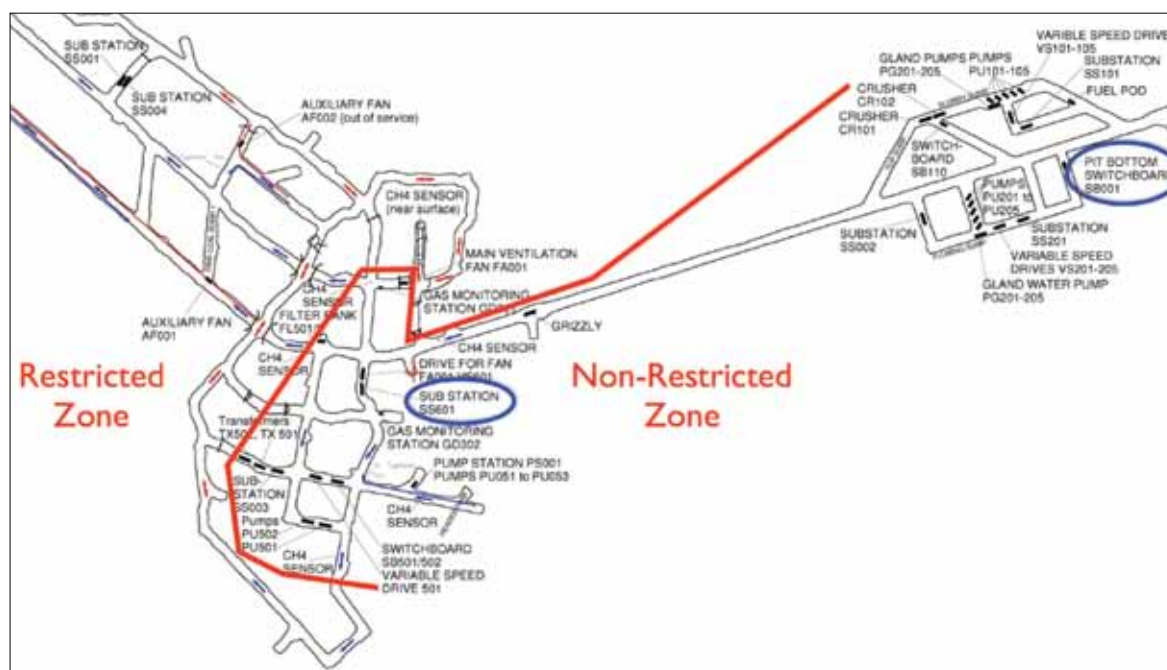
9. The red line in Figure 11.1 marks the boundary between two underground zones, the restricted zone, which is to the left of the line and includes the coal workings, and the non-restricted zone to the right. That non-restricted zone includes Spaghetti Junction and much of pit bottom south. The zones are explained below.

Figure 11.1: Main electrical area and zones underground<sup>2</sup>

15. By then Pike had already installed a large amount of electrical equipment, some of which was neither intrinsically safe nor flameproof, in the pit bottom south and Spaghetti Junction areas of the mine. The motor for the main fan, numerous pumps and VSDs fell within that non-restricted zone as defined.<sup>8</sup>

17. Despite those precautions, the non-restricted zone in pit bottom south extended to the coal measures in the gassy mine and was close to the return. Michael Scott, an underground electrical co-ordinator at Pike, noticed that some of the methane sensors in the non-restricted zone in 'pit bottom south near switchboard SB501 would trip. This was because the tunnel where the header tank is located is a non-free ventilated stub, or dead end, and we did have methane coming out there in small amounts ... very low concentrations, maybe 0.3%.<sup>10</sup> The sensor was moved and ventilation of the area improved. Methane greater than 0.25% in the non-restricted zone was reported though the accident and incident reporting system on at least one occasion.<sup>11</sup>
18. The location of the non-restricted zone did not go without comment at the mine. One deputy said:

21. A risk assessment would likely have led to the view that the non-restricted zone, and thus non-flameproof or non-intrinsically safe equipment, ought not to be located within or so near to the coal measures of a gassy mine or, if it was, very good protection would be needed to prevent methane coming into contact with electrical equipment.

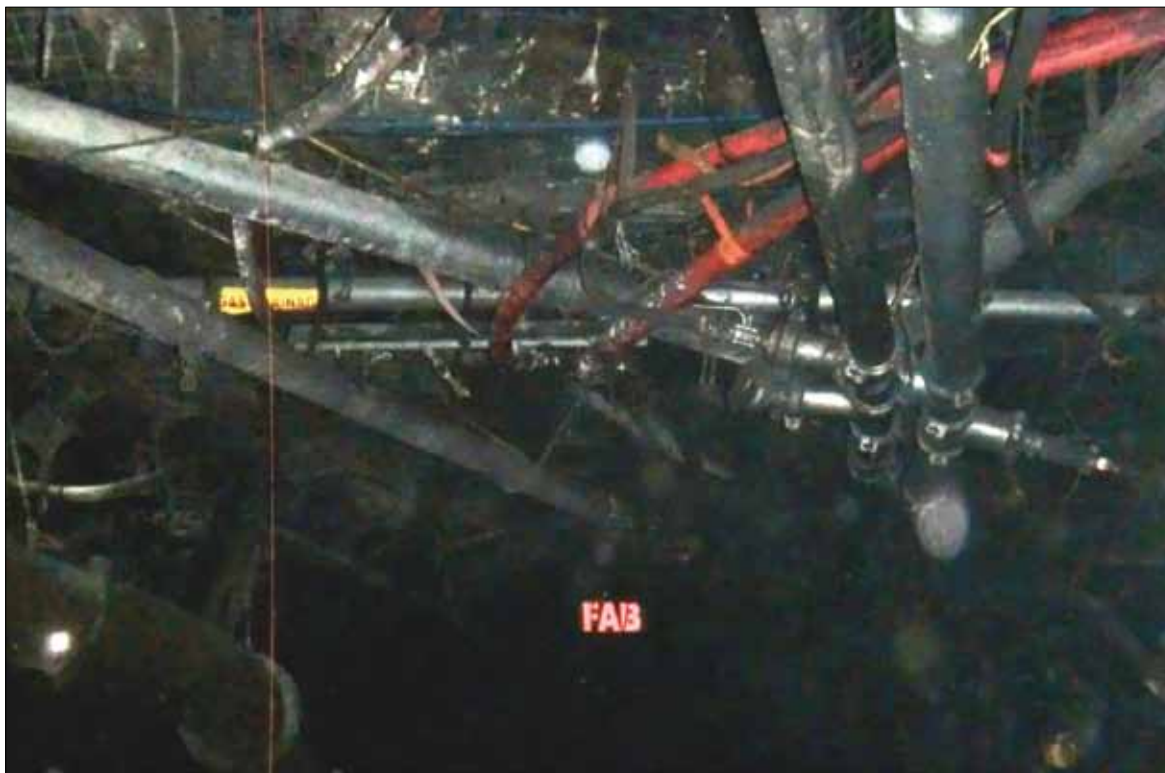
23. The inclusion of pit bottom south and Spaghetti Junction in the non-restricted zone led to another hazard. These areas contained roadways and significant utility services – water pipes, compressed air pipes and gas drainage pipes. To those were added 11kV lines. The sheer quantity, and lack of separation, of utility services at Spaghetti Junction is shown in Figure 11.2. The high-voltage cables are red.
24. Of that configuration mining consultant David Reece said:

*This is quite unusual to have pipes like this, this sort of configuration in a mining situation. The other thing is the high-tension cables that are also interspersed with all these services in that particular area. So this is potentially an area where these could be hit by a diesel vehicle or something of that nature ... it's certainly hazardous and the combination of services that you've got there with high-tension cables, and we're talking about 11,000 volts in those cables, if you damaged that at the same time as the pipeline, it is highly likely that you would get an ignition at that point.*<sup>17</sup>

**Figure 11.2: Spaghetti Junction**<sup>18</sup>

26. Comlek was concerned that high-voltage lines 'crossing the mine access road is considered dangerous due to it not specifying clearance heights by signage and not having indication of aerial location' and that standards of electrical equipment and location of storage needed 'major improvement'. An example was an item of electrical equipment (a starter) being located under water pipes, on the floor and without barrier identification.<sup>19</sup>

27. High-voltage cabling and electrical equipment should not be located close to gas, water and compressed air utility services. Where this is unavoidable, protective housing should be used, including protection against vehicle impact.

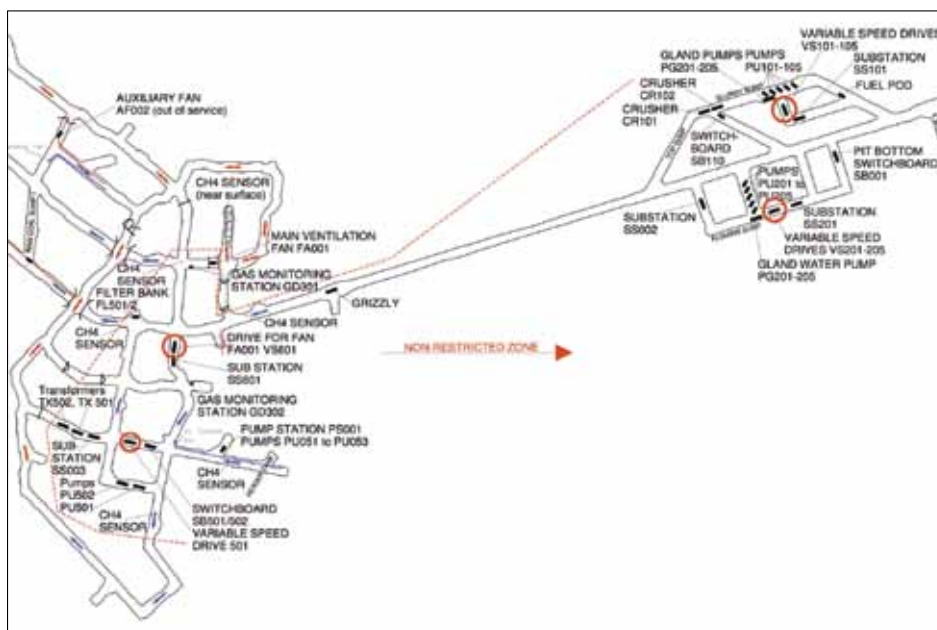
Figure 11.3: Plan showing VSDs underground at Pike River<sup>22</sup>

He had never seen a configuration such as that at Pike River, which was essentially a significant number of fixed VSDs underground.

31. Mr Reczek and Mr Nishioka gave evidence that VSDs need to be placed in a very clean, dust-free environment with a consistent temperature. Mr Reczek thought that 'unless you have a totally enclosed room which is dust free and filtered and separately ventilated, I don't think you could provide a satisfactory environment' underground in a coal mine.<sup>23</sup> Evidence indicates that Pike created, or sought to create, such an environment.<sup>24</sup>

33. There were other problems associated with the use of VSDs. There was an overvoltage in the power supply to at least one VSD, affecting its performance; this was rectified on about 9 November 2010. Five VSDs failed and were removed. In one case a power structure exploded. On several occasions pre-charge resistors failed. This problem was to be solved by changing the ratings of protective fuses. New fuses had been ordered but not replaced by the time of the explosion.

34. During commissioning of the main underground fan there were intermittent and difficult problems with the associated VSD. On 27 October 2010 the VSD was replaced with an air-cooled model, which was placed within an enclosure to provide protection. It seems this led to overheating. Pike took steps to correct that, including leaving open the doors to the enclosure and installing ducting to direct air into it. On about 9 November 2010 Pike ordered an air conditioner to improve the cooling. It had not arrived by the time of the explosion.<sup>26</sup>

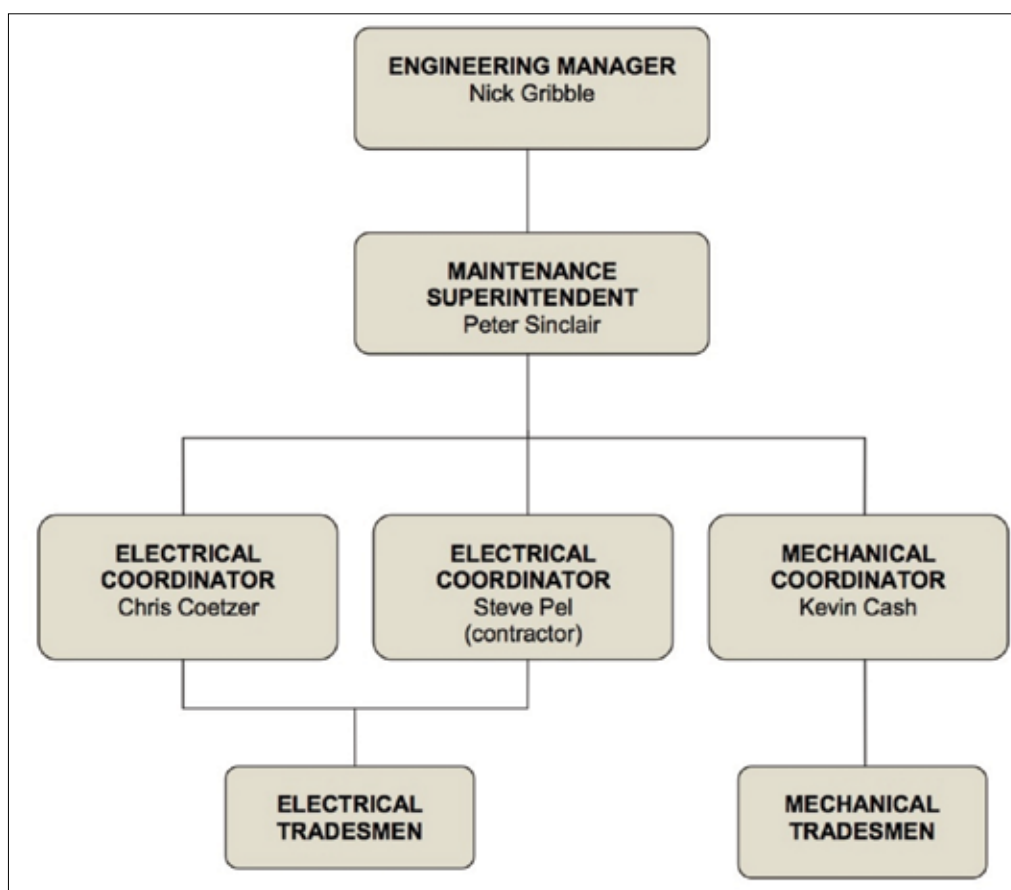
Figure 11.4: Structure of Pike engineering department before 24 August 2010<sup>38</sup>

*The current Pike River Engineering Department is currently unable to meet the needs of the business and a new engineering organisational structure has been developed to provide for the maintenance requirements of the business in an operational phase.*

*... The current structure does not have clearly defined areas of responsibility and fixed plant is not being proactively maintained due to lack of supervisory resources.<sup>40</sup>*

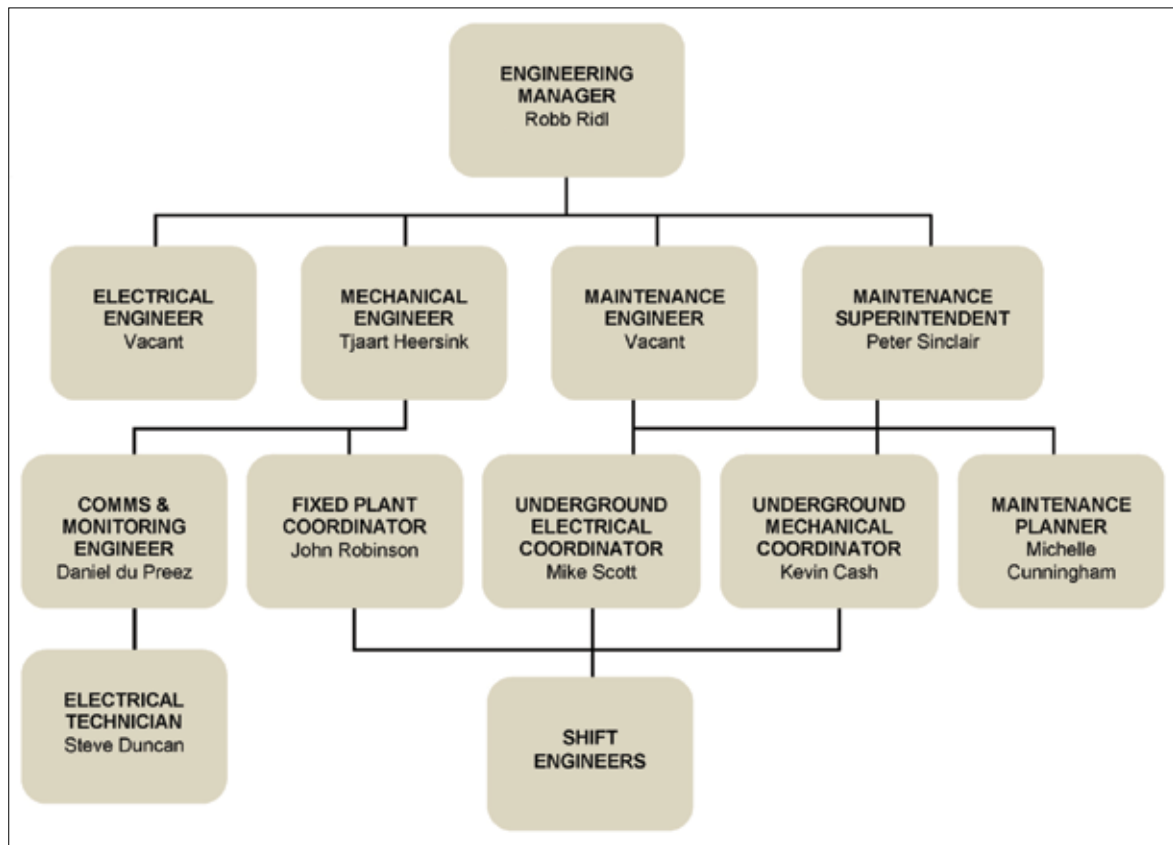
43. A new structure with increased staffing was proposed and was approved by Douglas White and Peter Whittall (see Figure 11.5).<sup>41</sup> It included the position of electrical engineer.
44. This was not as senior as the position suggested by Mr Reczek but did include responsibility for many aspects of the electrical system, including risk management, ensuring maintenance in accordance with statutory requirements, electrical inspections and continuous improvement.<sup>42</sup>

Figure 11.5: New structure for Pike engineering department<sup>43</sup>
