# The likely cause of the explosions

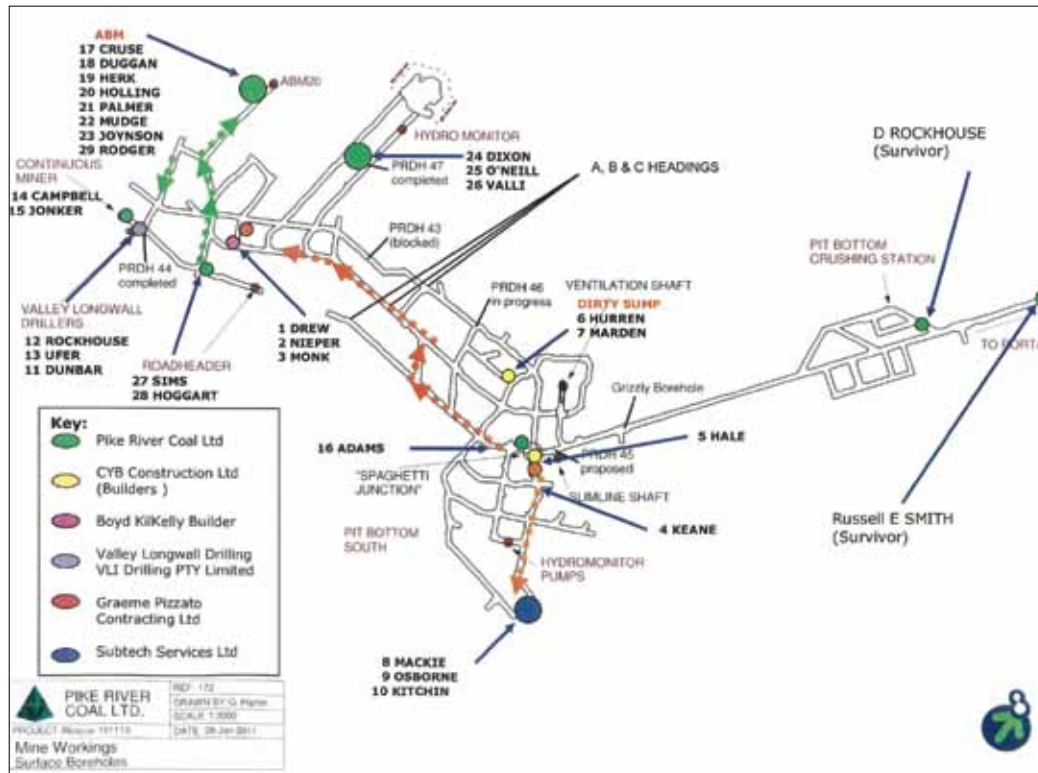
**Figure 14.1: Last known position of the 29 deceased and two survivors<sup>4</sup>**

The three main roadways running in parallel from pit bottom in a north-westerly direction are known as headings A, B and C from the bottom of the plan, with A heading still incomplete.

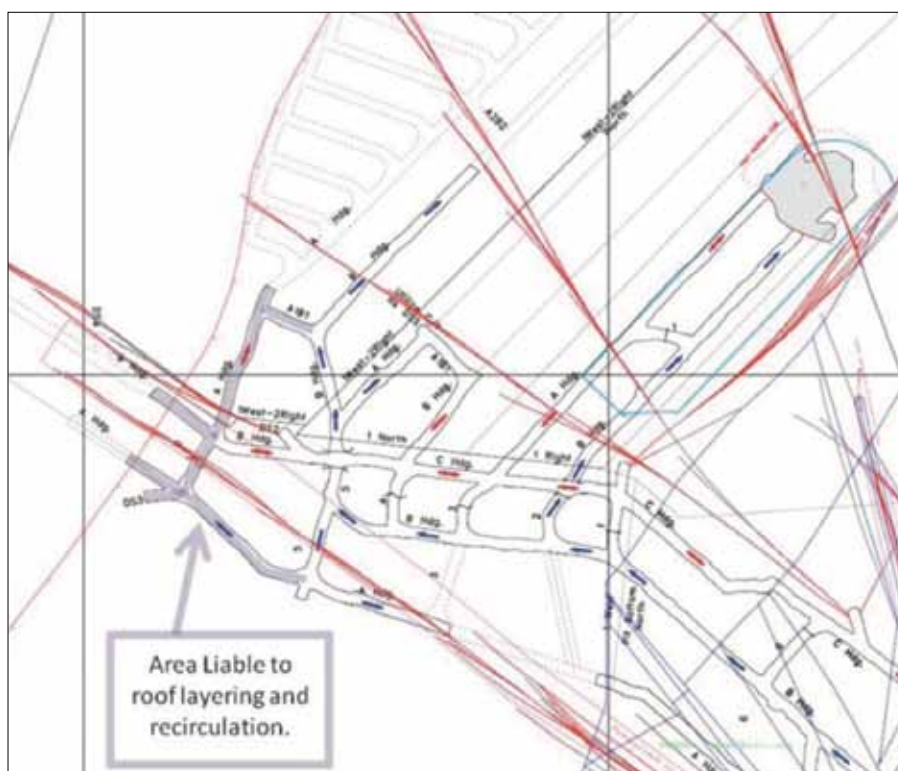
Figure 14.2: The area of the goaf and the intersecting borehole<sup>15</sup>

There was also a rider seam above the goaf which, after disturbance of the roof strata during mining activity, could leach further methane into the goaf.

35. The panel considered that up to 5000m<sup>3</sup> of methane could have built up in the goaf.<sup>16</sup> Methane is buoyant and would not move unless disturbed and flushed out during mining or expelled by a significant roof fall. The goaf was unsupported, so strata failure and roof falls were to be expected. Indeed, the mine had experienced a large goaf fall in October, and a flushing out of methane by the monitor during mining on 17 November. Both events expelled significant volumes of methane into the adjacent roadways.<sup>17</sup>

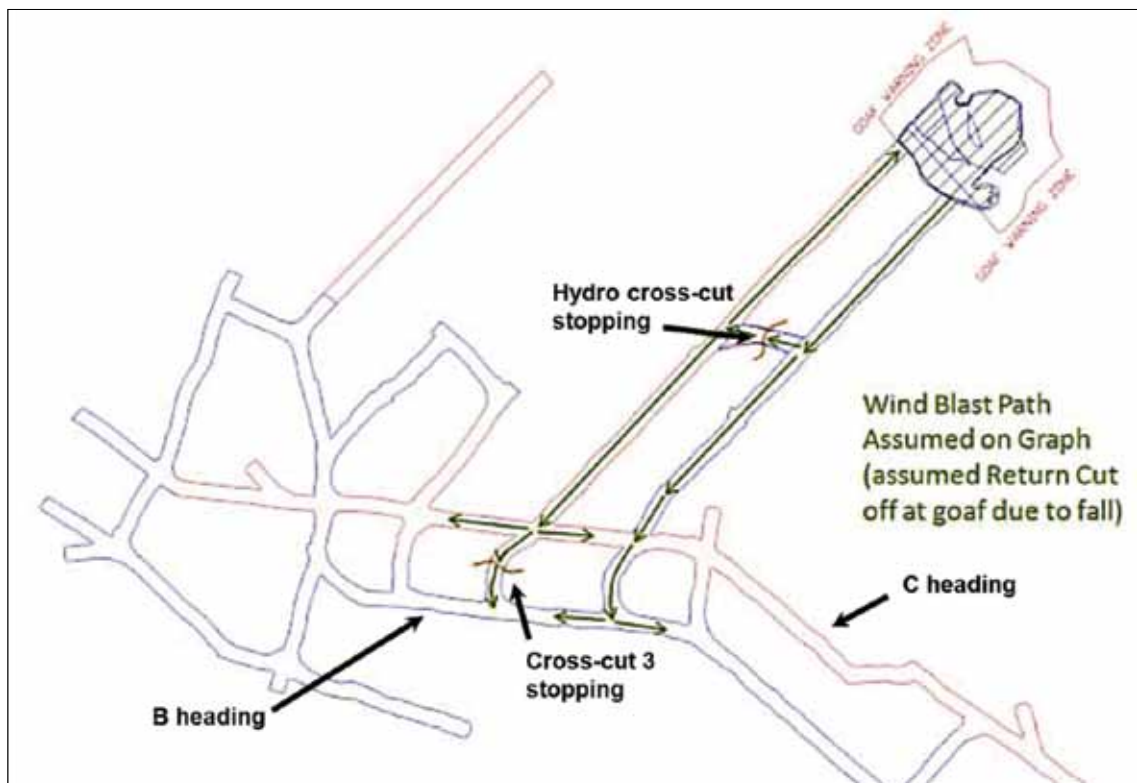
**Figure 14.3: Gas flow path due to goaf fall<sup>20</sup>**

40. The expert panel assumed that the return roadway from the hydro panel (left side of the diagram) would have been 'cut off at the goaf due to (the roof) fall'. Hence, the diagram depicts only methane expelled along the intake roadway (right side of the diagram) as far as B heading, and then flowing both inbye and outbye. In addition, it was thought that methane would be forced into the hydro panel cross-cut, would breach the stopping in this cross-cut

and travel in both directions along the return (left-hand) roadway. The southern flow was assumed to have crossed heading C, then breached the stopping in cross-cut 3 to reach B heading.

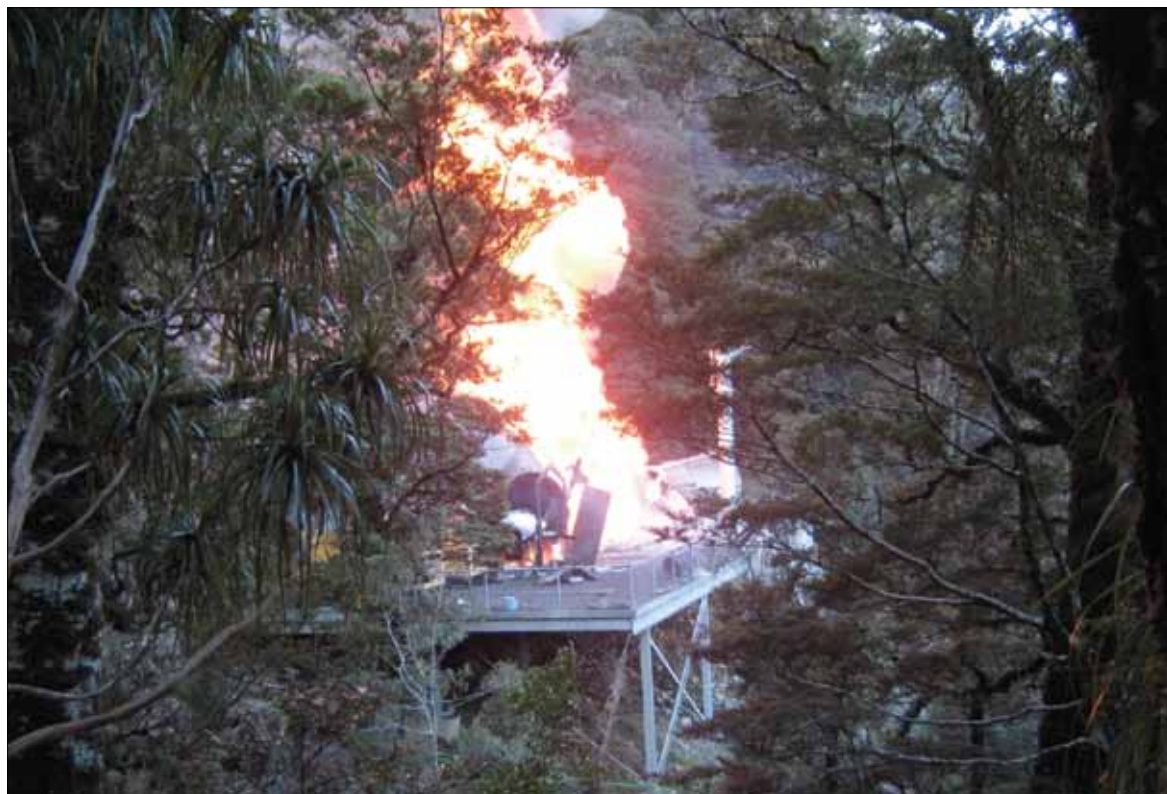
88. The later explosions differed from the first. The second and third explosions had a duration of 30 and 23 seconds at the portal, respectively. Both caused a much more forceful pressure wave than that from the first explosion. Following the pressure wave, air was initially drawn into the drift and then there was a reversal or expulsion of air.<sup>72</sup>
89. The fourth explosion was different again. It caused a billow of black smoke, followed by a fire ball out of the vent shaft and, subsequently, flames that diminished over time, but continued to be visible until 8 December.<sup>73</sup>

**Figure 14.4: Fire coming from the ventilation shaft following the fourth explosion<sup>74</sup>**
