Overview of best practice approach to methane drainage

The need for pre-drainage at Pike River

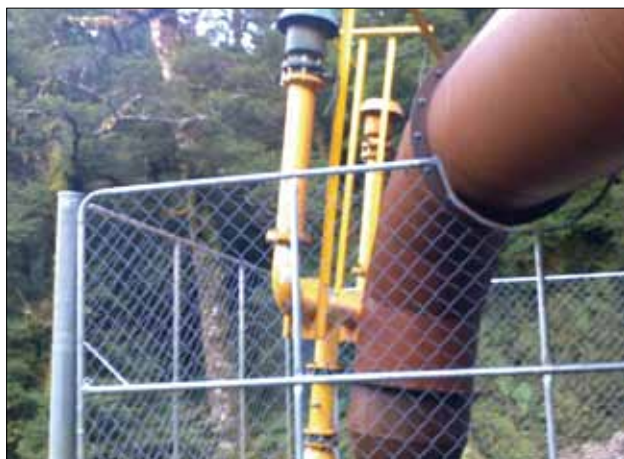
Figure 9.4: Gas riser and slimline shaft⁴⁵

53. The collapse of the ventilation shaft on 2 February 2009 severely limited mine ventilation. To recover air capacity, Pike drilled the slimline shaft from the same surface drill pad location it had recently used to install the gas drainage system. Figure 9.4 below shows the gas riser (yellow) with flame arrestors, and the brown pipe is connected to the top of the slimline fresh air shaft.

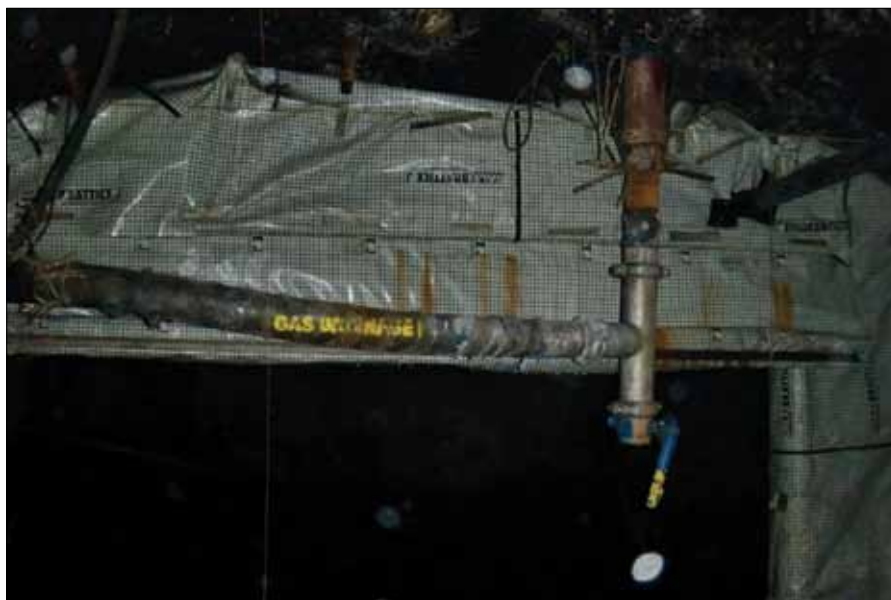
Figure 9.5: Bottom of gas riser at entrance to the FAB

54. The bottom of the 6" riser is shown below connected to the 4" gas drainage line labelled in yellow, at the entrance to what became the fresh air base (FAB) in mid-2010.⁴⁶

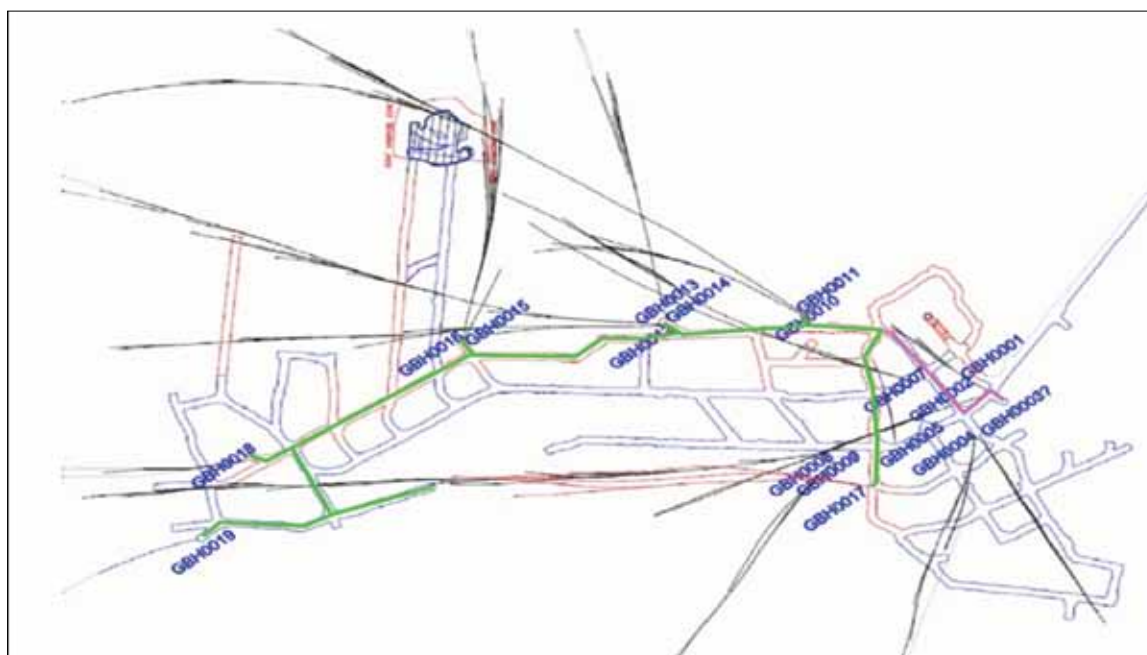
Figure 9.7: Gas drainage line and in-seam boreholes⁶⁷

68. Gas drainage pipelines carrying high-purity methane under pressure should be located in a mine’s return airway to minimise the risk of damage from blasting and mining equipment.

69. At the time of the explosion, the whole pipeline ran downhill to the riser, working against the natural inclination of methane to rise.⁶⁵ Significant pressure was required to force the gas along the 4” pipeline and to the top of the riser, and the pressure peaked at the highest point on the pipeline, at the drill stub. This led to difficulties for the drilling crews in managing water and gas from boreholes.⁶⁶

70. The pipeline was installed primarily in the return airways leading from connected boreholes outbye to the riser (as shown below in green), but it also ran for about 100m in the intake airway (shown in pink) from the overcast near the underground fan through Spaghetti Junction before turning left and then right to the gas riser located at the entrance to the slimline shaft/FAB. This created a significant hazard.

71. During a risk assessment into the operation of the ventilation fans held on 14 October 2010, an action plan recorded the need to move the methane drainage lines into a better area, away from the methane sensor at the main fan motor.⁶⁸ This had not occurred by 19 November 2010.
72. Staff from the technical services department disagreed with the decision to establish an FAB near the gas drainage line and riser, but the design decision was not theirs.⁶⁹ Mr Reece also criticised the decision:

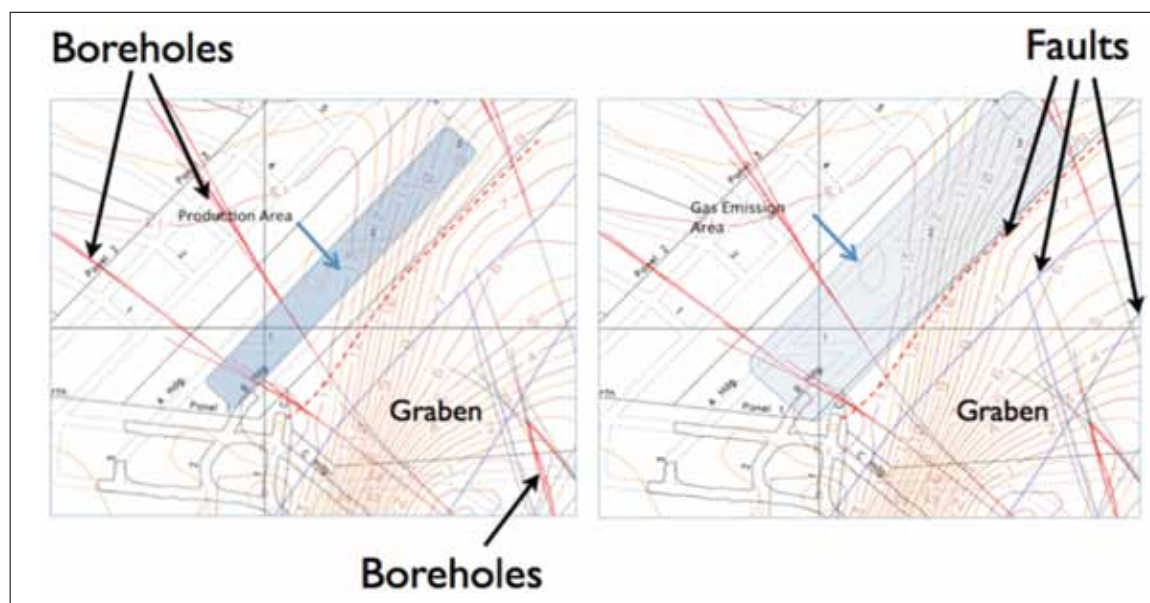
Figure 9.8: Panel 1 production area and panel 1 area of interest for gas emissions¹²⁹

109. The following diagrams show the proposed production area of the hydro panel, and the expected gas emission area for gas flows from the surrounding strata.¹²⁷ Long in-seam boreholes intersect the panel,¹²⁸ and faulting to the east of the panel is shown.

110. Borehole GBH016 was subsequently drilled 'flanking' the eastern boundary of panel 1, but no drainage holes were drilled within or to the west of the panel. GBH016 and the intersected boreholes were designed primarily for exploration of the seam, not for systematic pre-drainage of methane from the panel before mining.¹³⁰
111. The gas content core sample result of 8.29m³/t from GBH016 underlined the need for further drainage of the area, particularly given the use of an untried hydro-extraction method in a thick seam with the likelihood of high methane release. However, coal extraction from panel 1 began without pre-draining the seam down to safer gas levels.

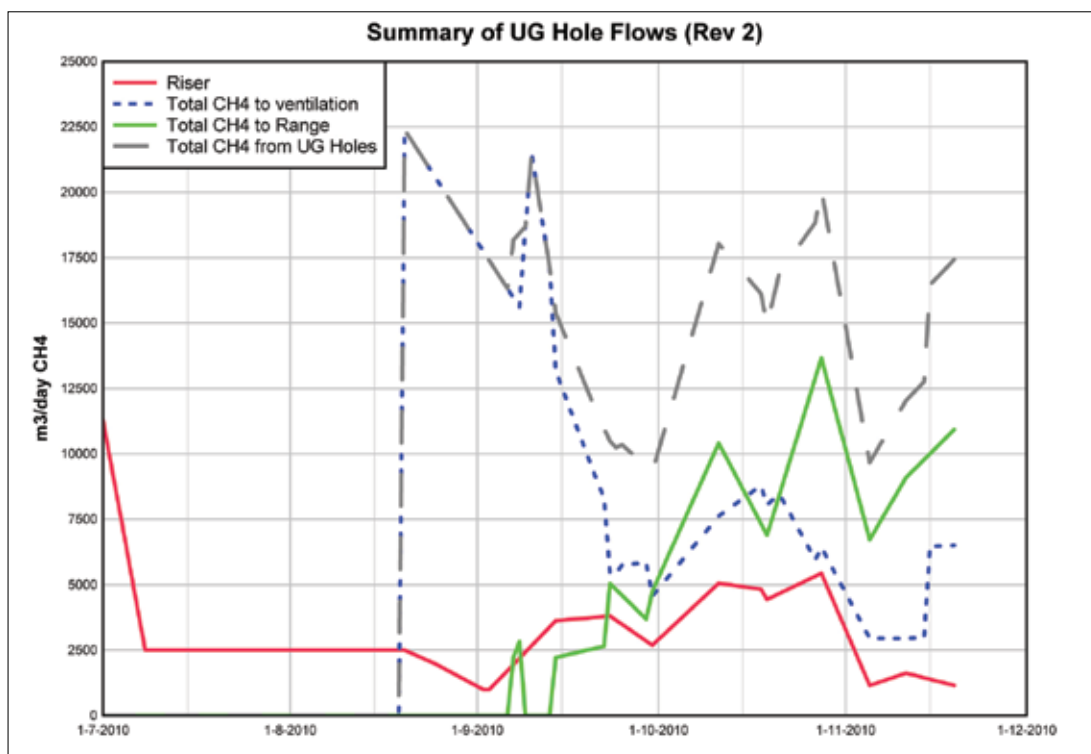
Figure 9.9: Graph summarising total daily drainage system gas flow measurements¹⁵⁰

126. The following graph prepared by the joint investigation expert panel¹⁴⁹ summarises the total daily methane volumes (m^3/day) for the drainage system gas from July 2010 until the explosion. The red line depicts the volume of methane measured at the bottom of the gas riser, which decreases from the beginning of July when the practice of free venting began with GBH012 disconnected from the range. The blue line shows the volume of methane free vented to the mine's atmosphere for dilution by ventilation; and the grey line shows the total methane flow from all boreholes. These measurements began on 20 August 2010, the start of gas flow measurement from individual boreholes. The green line shows the total methane volume flowing into the range from September 2010 when weekly gas drainage measurements commenced.

127. The noteworthy features are the high volume of methane free vented when compared to the volume of gas entering the range, and the difference between the volumes entering the range and reaching the bottom of the riser. For example, on the day of the explosion the measured gas flow into the range was 126.4l/s but only 13.3 l/s was measured at the gas riser. Such discrepancies dated back to the beginning of October. Various explanations for the difference have been suggested including leakage, methane back-feeding into other areas, a blockage in the range or incorrect measurements at the gas riser.¹⁵¹
128. As late as 27 October 2010, there was no accurate recording of methane emissions and no comprehensive system in place to capture, record and store all data permanently.¹⁵²
129. The expert panel criticised Pike's gas management approach:

Significantly, there was a lack of specific gas drilling design and implementation for adequate in situ gas reduction; a particularly inadequate gas drainage system with substandard pipeline dimensions and lack of evacuation (pumping); and little determination of in situ gas content (cores) linked with an authority to mine.¹⁵³
