## Introduction

1. This chapter summarises the hydro-mining systems used at Pike River, and assesses the management, safety and effectiveness of the company's hydro-mining operation.

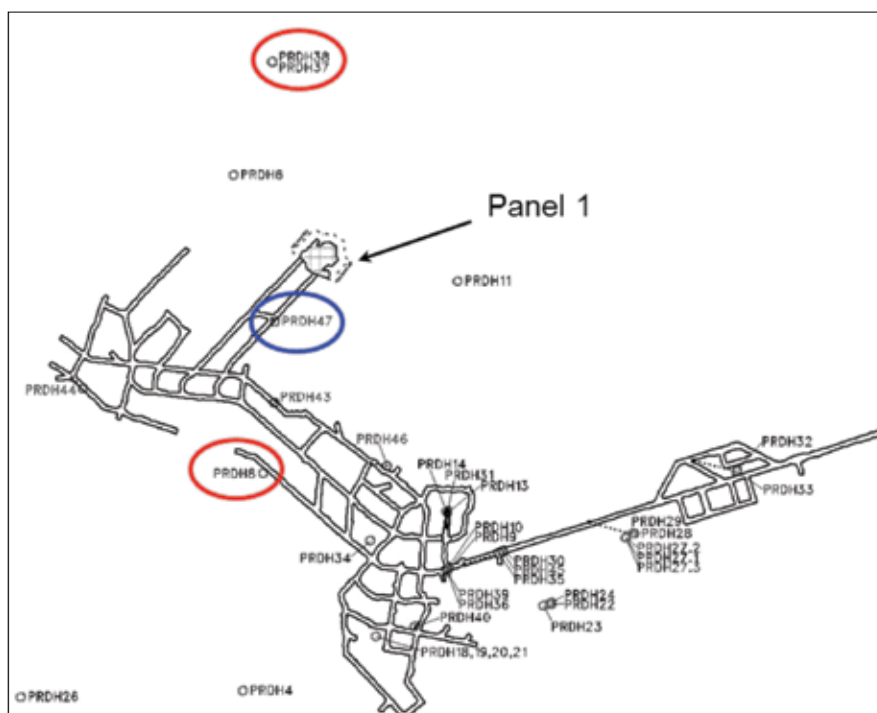
Figure 12.12: Drillholes in the vicinity of Panel 1<sup>77</sup>

65. There was no vertical borehole in the area of the hydro panel, so the only geotechnical data available was from vertical drillholes PRDH8 and PRDH37. These were some distance apart to the south and north of panel 1, as shown below circled in red. PRDH47 (shown below circled in blue) was not drilled until after the explosion.

68. Pike had two main options to obtain more geological information. First, it could have drilled another vertical borehole from the surface above the hydro panel. This would have been expensive and further delayed the start of hydro extraction. Pike did not pursue this option.
