# The promise of Pike

## Introduction

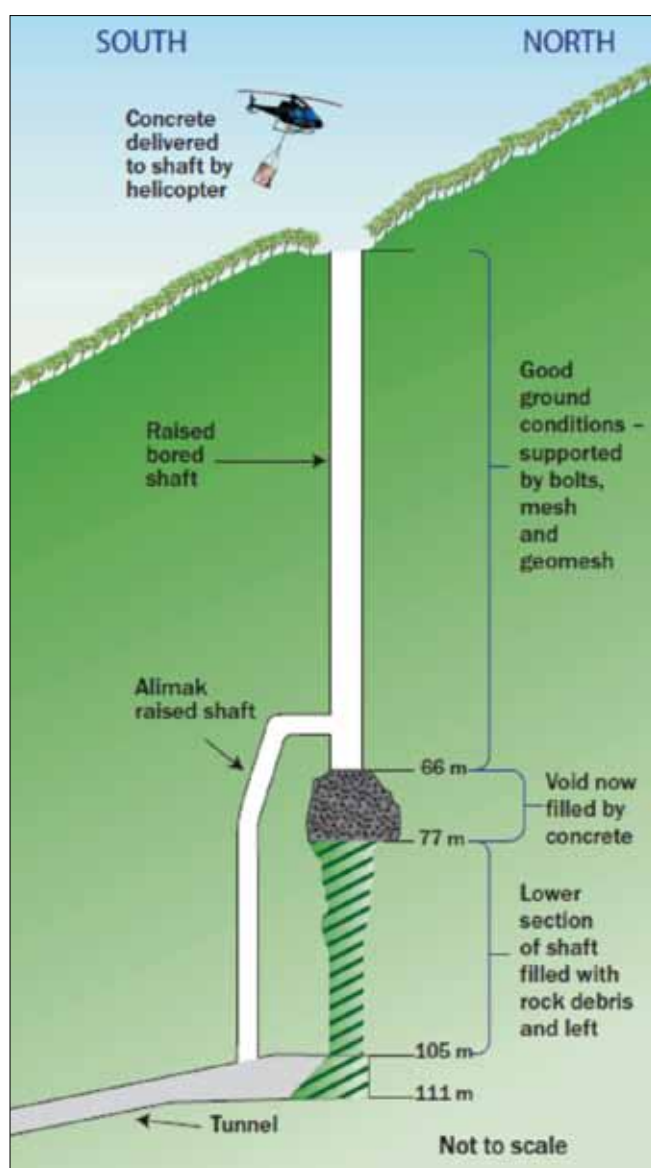
Figure 3.7: Ventilation shaft and Alimak raise<sup>38</sup>

48. But the shaft could not be completed until the drift was through the Hawera Fault and a roadway was driven to the ventilation shaft site. In December 2008 a bore began to ream out the shaft from the bottom up to the surface. This was completed in January 2009, but in early February 2009, before the 4.2m diameter shaft was fully lined, the bottom section collapsed, sealing any connection between it and the mine roadway.<sup>37</sup>

49. Following investigation the company decided to abandon the bottom 35m, cap it with concrete and construct a bypass to reconnect to the upper 70m of the shaft, as shown in the diagram.

The bypass, called the Alimak raise, was constructed between April and June 2009. The raise was only 2.5 by 2.5m, and connected to the 4.2m diameter shaft. Obviously, the cost of the Alimak raise was unexpected, as was the five-month delay.
