## CHAPTER 8

# Ventilation

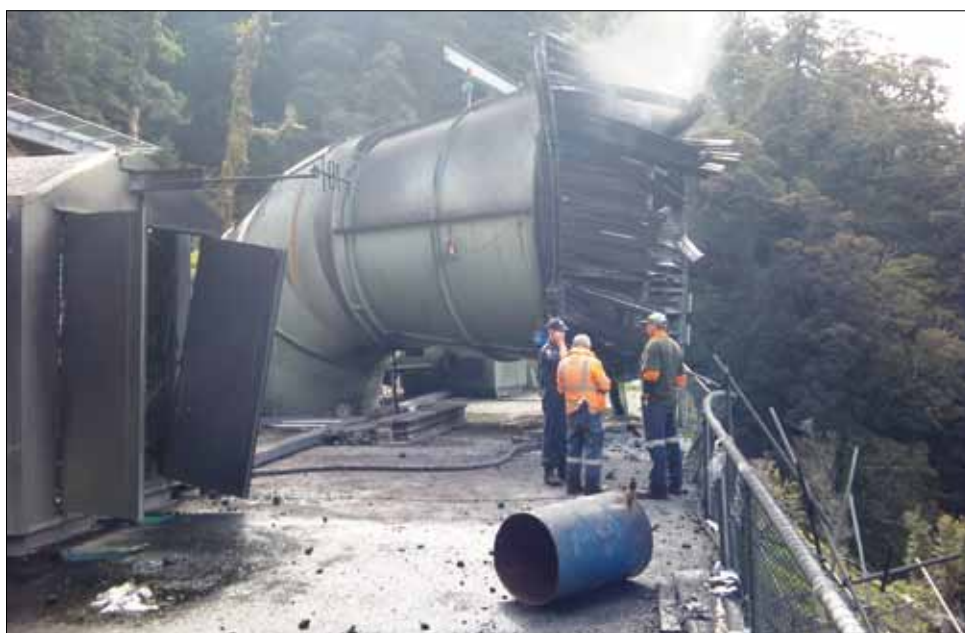
82. The surface fan failed in its vital back-up role. As shown in the photograph below, the explosion panels failed to divert the explosive air flow and debris from the first explosion, which damaged the fan, fan housing, shaft access doors, power generator and control infrastructure. Subsequent explosions propelled the fan and housing from their fixed positions.<sup>118</sup>

Figure 8.10: The surface fan after the first explosion

83. Gregory Borichevsky and an electrician examined the damage to the surface fan on 22 November 2010, before the second explosion on 24 November damaged it further. The airlock doors in the fan housing and the louvres installed on the evasé had been blown open and damaged. The fan was intact but three of the fan blades were damaged. The control panel had been blown over by the force of the blast coming out of the airlock doors and had fallen onto the emergency stop button of one of the generators.<sup>119</sup> The DOL investigation report concluded that the surface fan did not start at all, but it appeared that at least one of the diesel generators had started, since some fuel had been used.<sup>120</sup>

85. It is evident from the damage to the surface fan installation that the explosion panels could not cope with the explosion. The fan was too close to the ventilation shaft because of the limited space available at the site. The damage suffered meant the surface fan could not reventilate the mine.

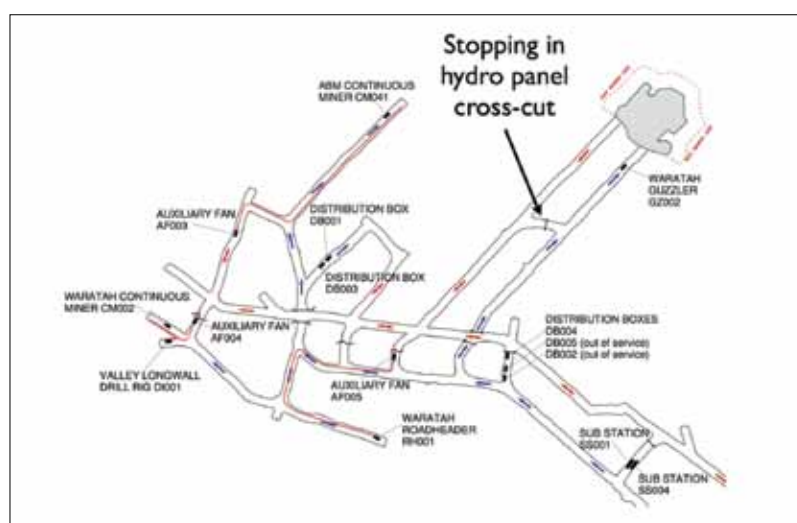
116. On 30 October 2010 there was a large roof fall in the goaf in the hydro panel. The roof fall generated a pressure wave that knocked over the stopping at cross-cut one in the hydro panel, marked in the diagram below.

Figure 8.14: Stopping in hydro panel cross-cut<sup>165</sup>

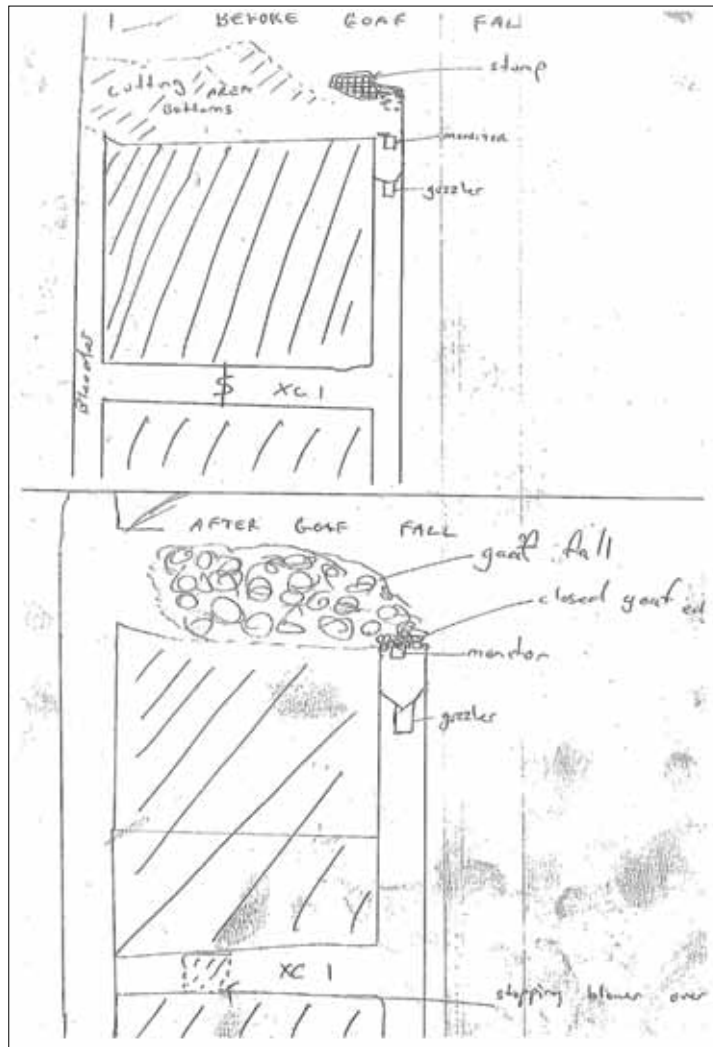
119. Mr Wylie completed an incident report.<sup>170</sup> He attached a hand-drawn diagram showing the effects of the roof fall, including the blocked heading at the entry to the goaf and the damaged stopping in cross-cut one, with the words 'stopping blown over'.

**Figure 8.15: Effects of roof fall on 30 October 2010<sup>171</sup>**

121. This incident provided a warning of a major hazard. It demonstrated the vulnerability of the mine's stoppings, as well as the potential for a roof fall in the hydro goaf to damage the ventilation system and lead to an explosive accumulation of methane.

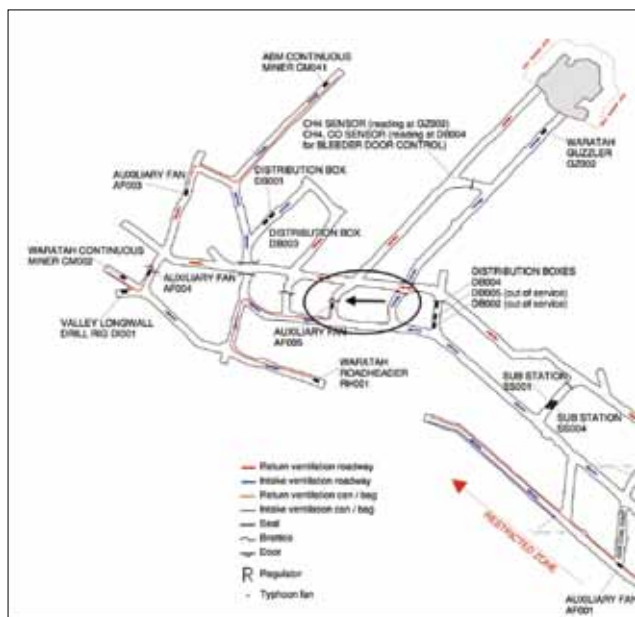
126. The DOL investigation stressed the significance of the stopping at cross-cut 3, marked with an arrow below.

Figure 8.16: Hydro panel and cross-cut 3<sup>184</sup>

127. That stopping was directly in line with the return from the hydro-monitor panel. Any significant roof fall in the hydro goaf would create an overpressure down the return, and the stopping would need to withstand that pressure.
128. Despite that risk, the stoppings at cross-cuts 3 and 4 remained in a temporary state on 19 November 2010. The collapse of the stopping at cross-cut 1 in the hydro panel on 30 October 2010 had served as a warning of this vulnerability, but Mr White said it was 'not likely' any consideration was given to the matter, even following the 30 October incident.<sup>185</sup>
129. Mr van Rooyen agreed with the criticism of the stopping at cross-cut 3, and said it 'should have been made permanent preferably before or certainly early on in the excavation of the hydro panel'.<sup>186</sup> He agreed that the

increasing size of the goaf created a greater risk of a roof fall, resulting in damage to the temporary stopping in cross-cut 3, which could allow the short circuiting of air away from the inbye faces, and might also allow methane to enter the intake roadway.<sup>187</sup>

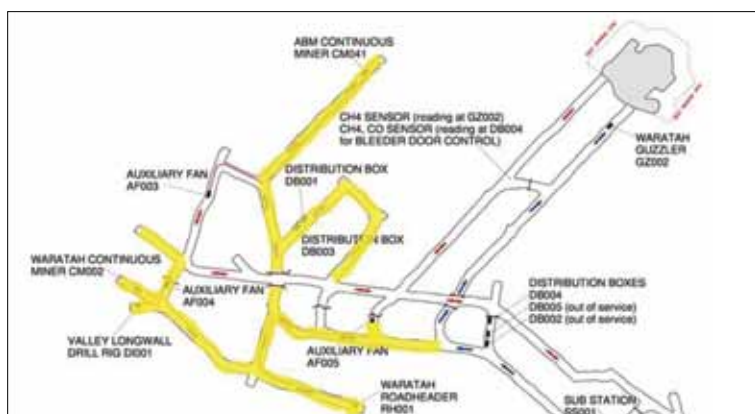
135. Ventilation inbye of the monitor panel was particularly fragile and struggling to cope with the extent of mining operations and gas load in the mine.<sup>197</sup> Those areas had a small amount of pressure (14Pa) and quantity (49m<sup>3</sup>/s) available to ventilate the three working places and two standing places inbye of panel 1. That area is shaded yellow in the following diagram.

Figure 8.17: Ventilation inbye of the monitor panel<sup>198</sup>

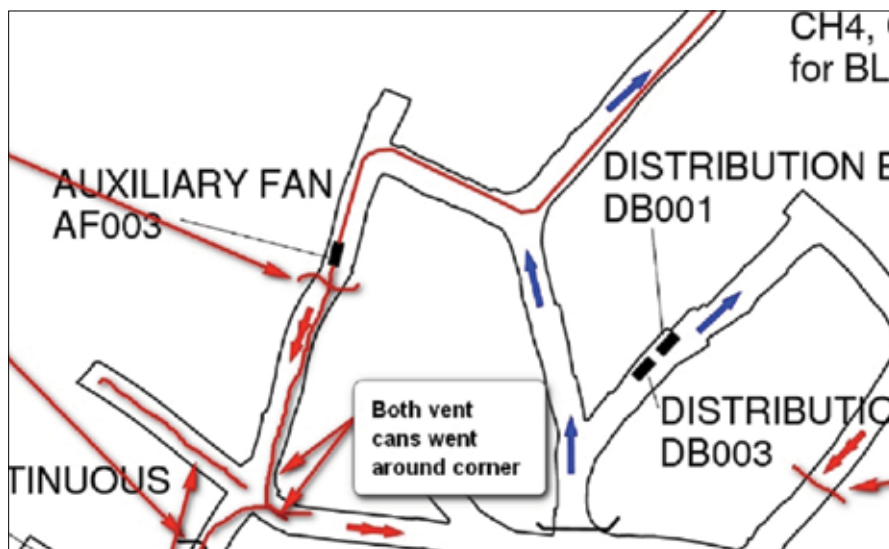
136. DOL concluded that, given the gas make in the mine and the number of faces being worked, it should have been apparent that the ventilation system was stretched to its limit. Pike's approach allowed no factor of safety to deal with predictable hazards.<sup>199</sup>
137. Mr Reece also noted other deficiencies with the ventilation system, for example, the placement of an auxiliary fan (AF003) immediately next to a stopping,<sup>200</sup> which meant the fan did not have the necessary 30% of fresh air passing over it to ensure it did not overheat. The fan can be seen towards the left-hand side of the following diagram.

Figure 8.18: Location of the auxiliary fan<sup>201</sup>
