# Part 1

+ What happened at Pike River

# Friday afternoon, 19 November 2010

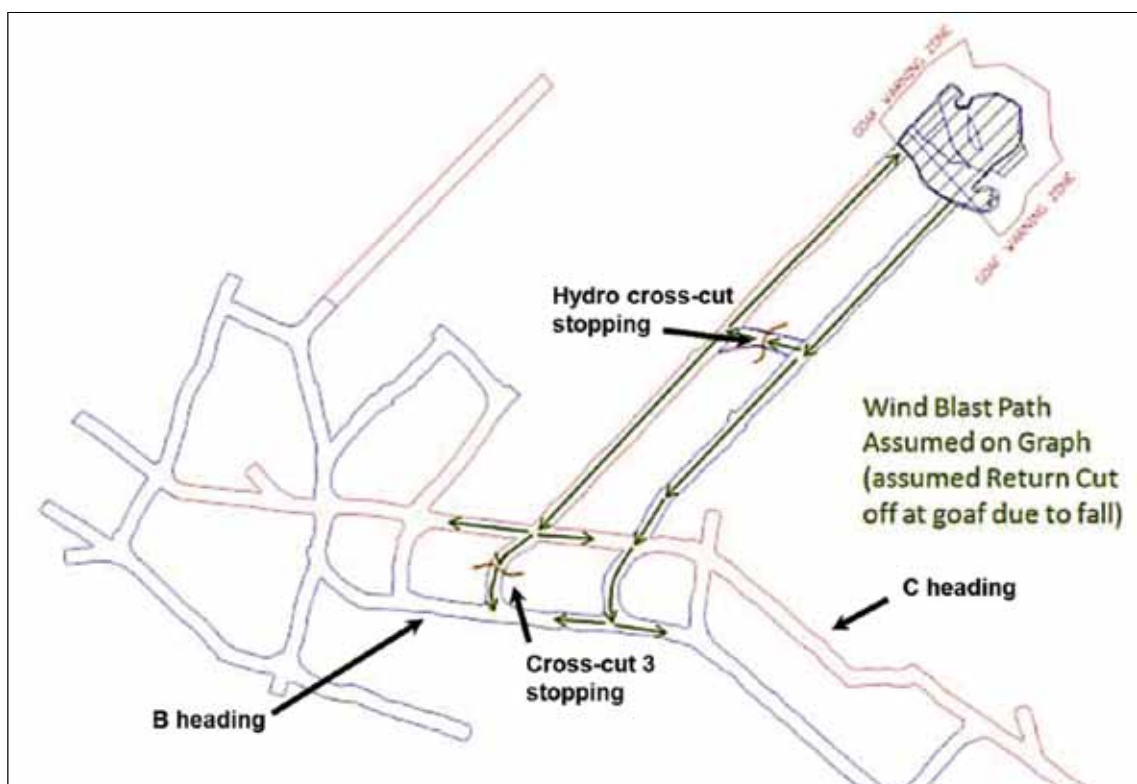
**Figure 14.3: Gas flow path due to goaf fall<sup>20</sup>**

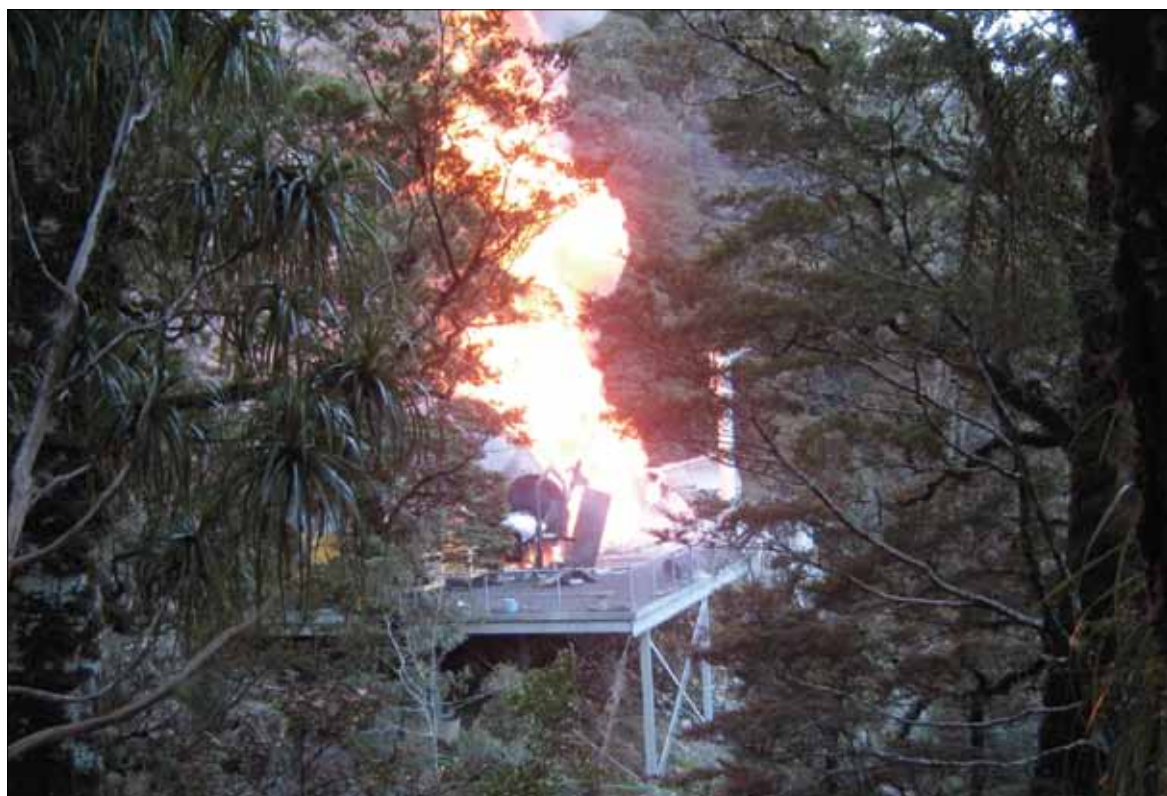
**Figure 14.4: Fire coming from the ventilation shaft following the fourth explosion<sup>74</sup>**
