# снартег 10 Gas monitoring

# Introduction

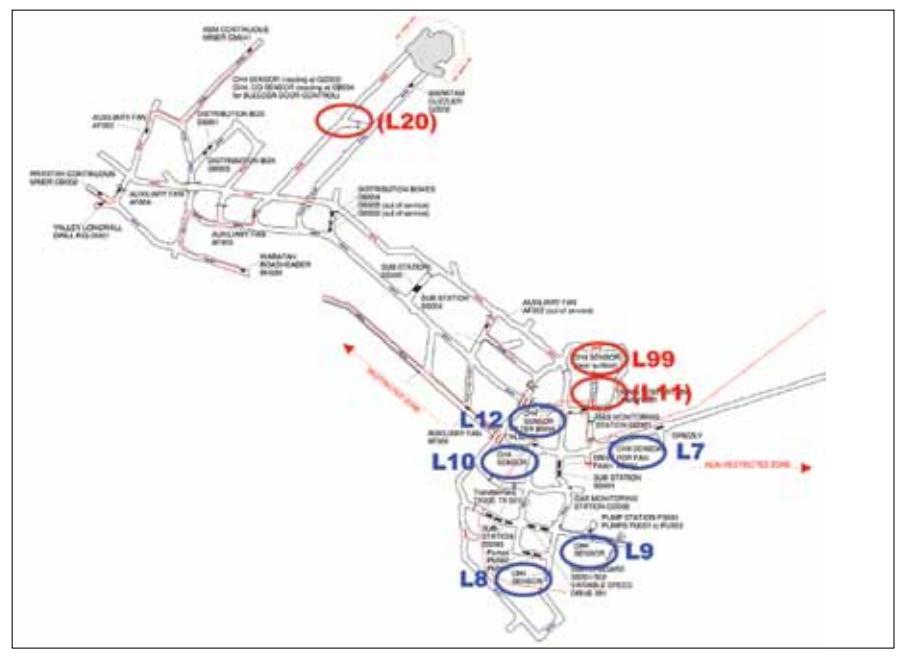
Figure 10.1: Location of fixed methane sensors<sup>22</sup>

12. The five sensors circled in blue were all located within the intake roadways, in areas expected to be ventilated by fresh air. These sensors were located at or near electrical equipment in an area Pike designated as the 'non-restricted zone'. Regulations require the non-restricted zone to contain no more than 0.25% flammable gas. The sensors in this area at Pike River were set to trip power at 0.25% methane.

- 13. The three sensors circled in red were in the return of the ventilation system, and were intended to measure the concentration of methane in the contaminated air removed from the mine workings.<sup>23</sup>

- 14. The sensor at L11 stopped working on 4 September 2010,<sup>24</sup> and the sensor at L20 stopped working on 13 October 2010,<sup>25</sup> leaving Pike with no gas sensors reporting to the surface from further into the return than the ventilation shaft. This did not give the mine adequate information about the location, source and quantities of flammable gas within the mine. Surface controller Barry McIntosh said the controllers had raised the issue of the location of gas sensors, and in his view the gas sensors 'weren't up far enough' in the mine.<sup>26</sup>

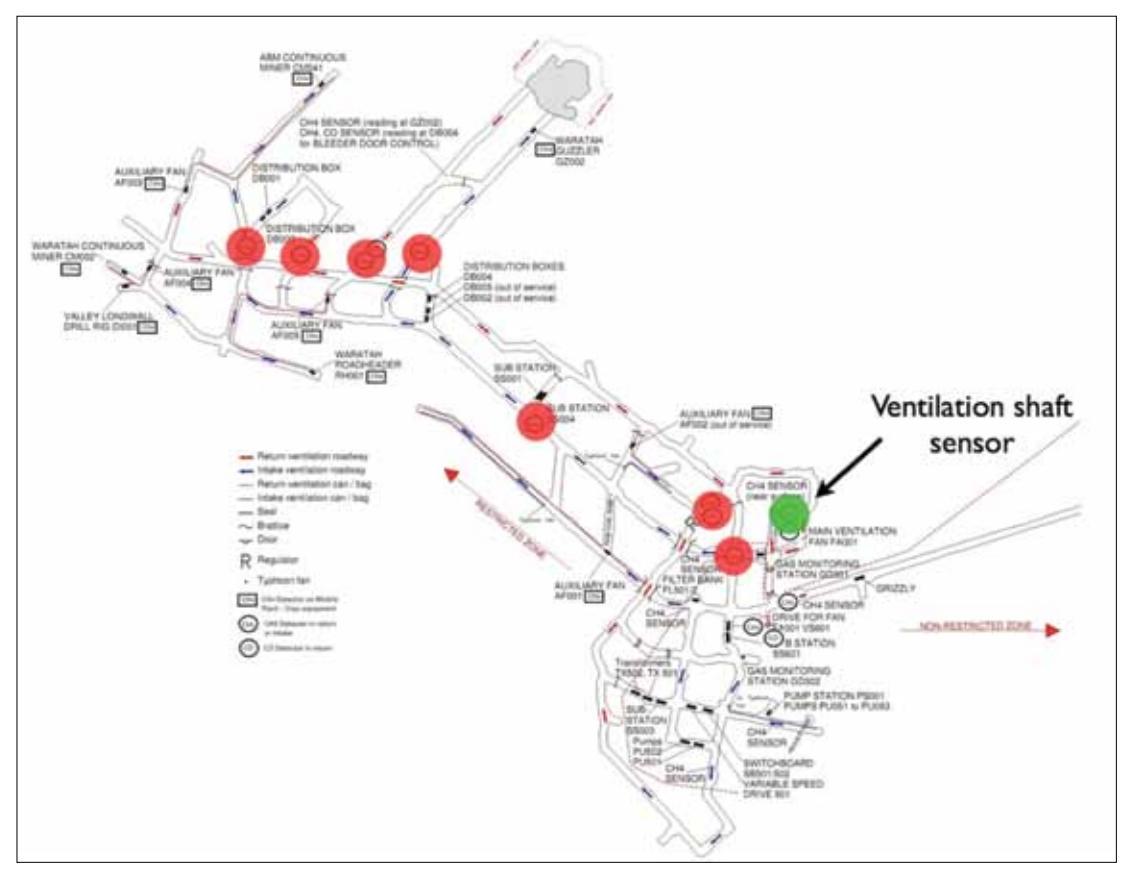
#### Figure 10.2: Plan of required gas sensors at Pike River under Queensland legislation<sup>27</sup>

- 15. By way of comparison, consultant David Reece provided on request a plan showing where Pike would have typically required gas sensors under Queensland legislation. His plan was not absolute and was subject to a number of technical qualifications including the proximity of other detectors, but on the basis of the plan, Pike would probably have required seven fixed sensors (marked in red) reporting to the surface from inbye of the ventilation shaft. As at 19 November Pike did not have any fixed gas sensors reporting to the surface in these areas. The only functioning sensor reporting to the surface from the return was at the position marked in green on the plan.

16. The joint investigation expert panel said that the mine 'should not have operated' without at least two sensors in the return, connected to an alarm and set to trip the power supply for the underground fan.<sup>28</sup>

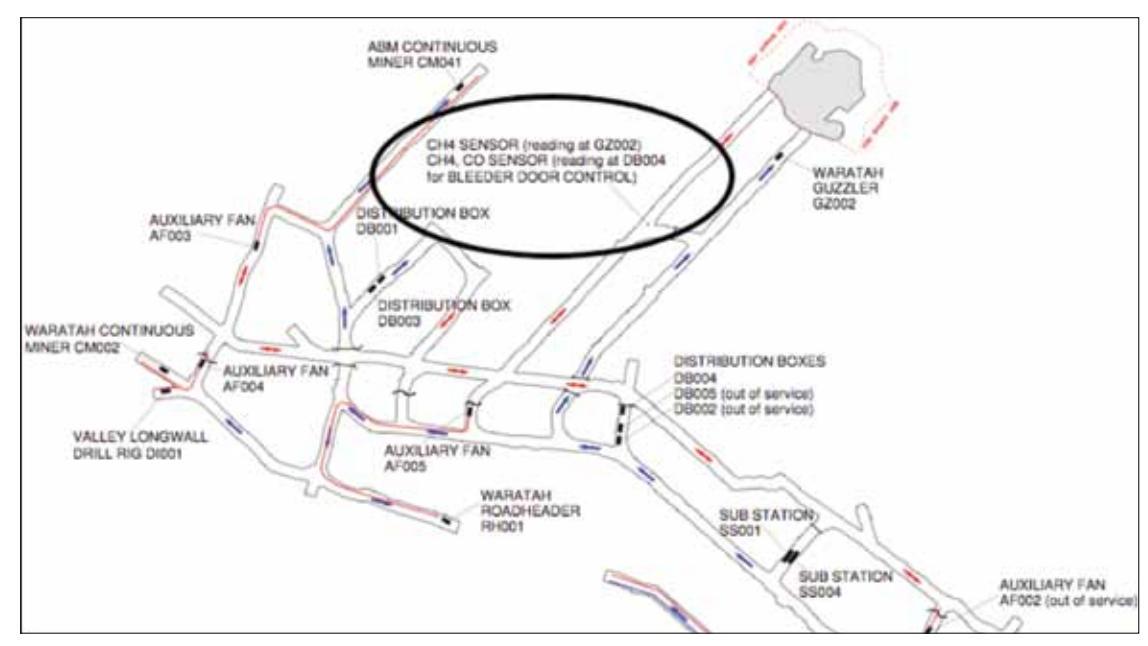
Figure 10.3: Location of hydro-panel sensors<sup>29</sup>

17. There were two methane sensors located in the return from the hydro panel, circled in black on the diagram below.

18. One provided a reading at the guzzler near the hydro monitor, but did not report to the surface or result in any permanent record of gas levels. The other sensor had been exposed to methane concentrations above 5%, and did not work after 13 October 2010.<sup>30</sup>

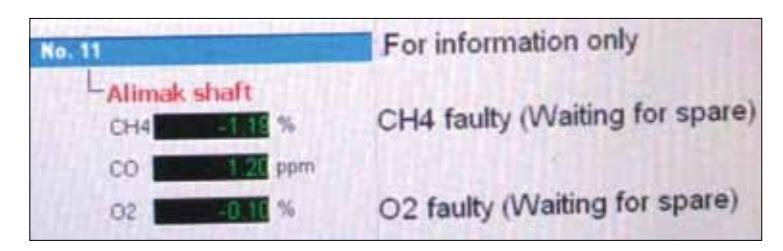
19. There were several problems with the gas sensors in the ventilation shaft. First, the sensor at the bottom of the ventilation shaft stopped working on 4 September 2010, nearly 11 weeks before the explosion, and was never repaired or replaced.<sup>31</sup> Indeed, the control room operator's screen on the Safegas system was permanently annotated to say the sensor was 'faulty' and 'waiting for spare'.

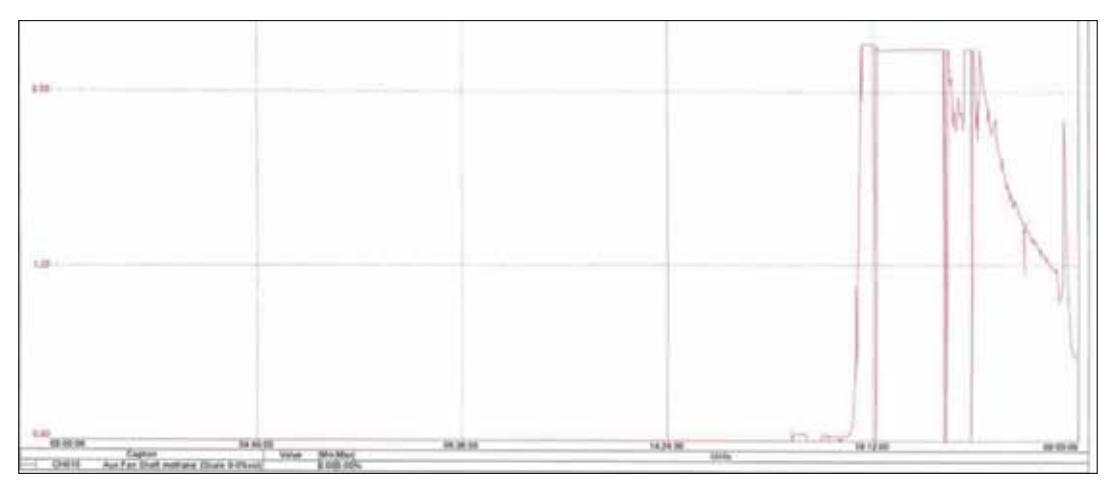
Figure 10.5: Auxiliary fan shaft methane – 6 October 2010<sup>43</sup>

- 24. The ventilation shaft sensor also 'latched' or was poisoned on a number of occasions, causing a flat line to show on the surface controller's system. The flat line phenomenon indicated the sensor had been exposed to greater than 5% methane. This occurred during the 'gassing out' of the mine on Wednesday 6 October 2010, after the failure of the surface fan.

- 25. There was no data from the sensor from the time of the fan failure on 5 October. The control room system then showed a flat line around 2.5% during the evening of 6 October. Despite a review and a notification to the Department of Labour (DOL) about the incident, nothing was done about the flat line issue.
- 26. There was then a second flat line that started late on Thursday 7 October and continued through to Friday 8 October 2010 during the degassing procedures.

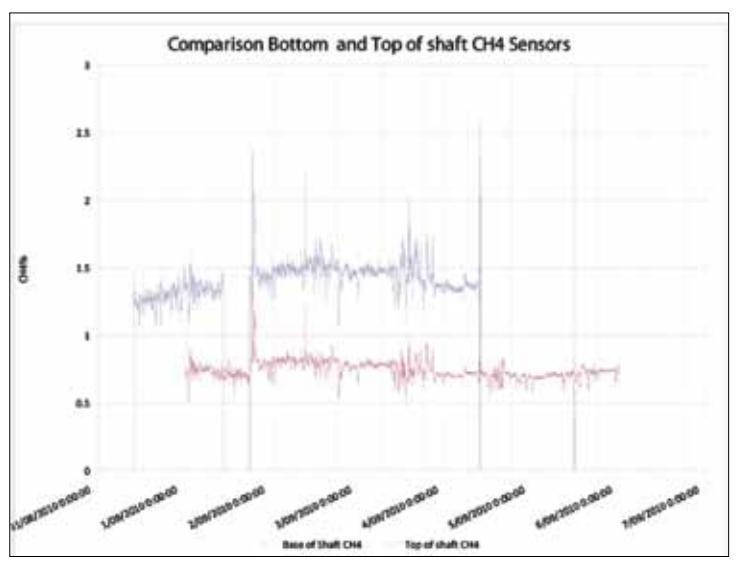
Figure 10.7: Comparison bottom and top of shaft CH<sub>4</sub> sensors<sup>47</sup>

- 27. Mr White told the commission he was not aware of any flat lines, and if he had been, it would have been a cause for investigation.<sup>45</sup> However, he accepted that he signed a ventilation survey dated 7 October 2010 that said in red capital letters 'Had a spike of 2.8% at vent shaft monitor stuck on this reading.'<sup>46</sup>
- 28. Third, while the sensor at the bottom of the shaft was operational, there was an obvious discrepancy between the readings at the top and bottom of the shaft. The discrepancy is shown in the following graph prepared by DOL, which shows the reading from the top of the shaft in red, and the reading from the bottom of the shaft in blue.

- 29. There was an obvious question to be answered given that two sensors in the same air stream were reading so differently.<sup>48</sup> The discrepancy was not investigated.<sup>49</sup>
