## CHAPTER 8

# Ventilation

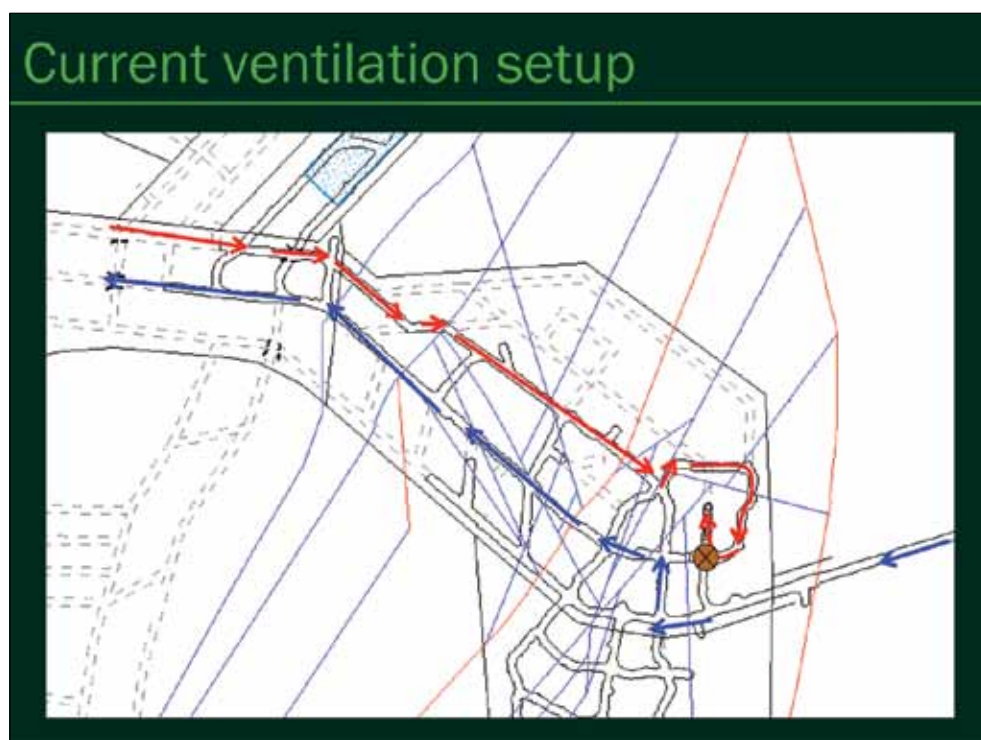
**Figure 8.4 : Current ventilation setup<sup>61</sup>**

46. Pike's early planning contemplated multiple intakes beyond the first year of development.<sup>60</sup> In November 2010 the Pike River ventilation system was still a one intake and one return system, as shown in the following diagram:

47. The blue arrows depict fresh air entering through the intake (main drift), circulating through the workings and exiting through the return, shown in red. The main underground fan is depicted as a circled X towards the bottom right of the diagram, at the base of the ventilation shaft. Mr van Rooyen presented this simplified diagram of the Pike ventilation system to the Pike board in August 2010.

49. The second intake was still planned. Mr van Rooyen presented the Pike board with a number of options in August 2010.<sup>64</sup> He estimated that it would have taken about a year for Pike to reach the recommended location of the second intake from the time he left in November 2010.<sup>65</sup>

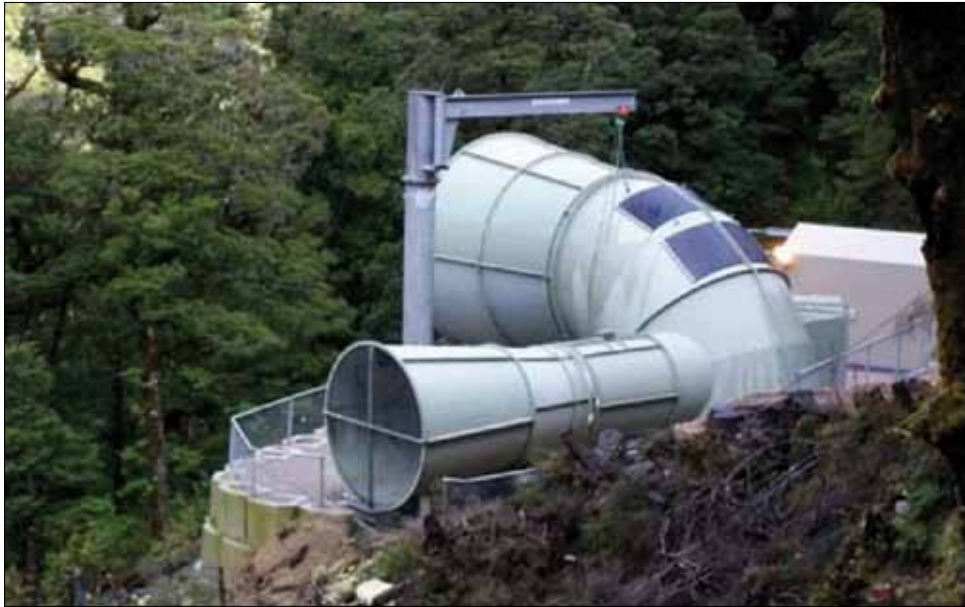
**Figure 8.5: The surface back-up fan**

50. Pike installed the surface back-up fan at the top of the ventilation shaft in June 2009. The exhaust structure (evasé) for the surface fan is on the left in the photograph, and the larger evasé is for the main underground fan.

53. On the top of the housing were four explosion panels, designed to allow a pressure wave of air and debris following an explosion to go straight through the top of the housing and minimise damage to the fan. The explosion panels are seen in black in Figure 8.5.
54. Because both the surface fan and main underground fan were connected to the same ventilation shaft, a system was needed to block off air flow through one or other easé, depending which was in use. Initially Fläkt Woods designed a butterfly damper for that purpose, but this was damaged and not repaired for 12 months or more.<sup>69</sup> During commissioning of the underground fan a few weeks before the explosion, Pike installed a set of louvres at the end of the main fan easé as shown below. These were designed to close if the main fan stopped and the surface fan started up to ventilate the mine.

82. The surface fan failed in its vital back-up role. As shown in the photograph below, the explosion panels failed to divert the explosive air flow and debris from the first explosion, which damaged the fan, fan housing, shaft access doors, power generator and control infrastructure. Subsequent explosions propelled the fan and housing from their fixed positions.<sup>118</sup>

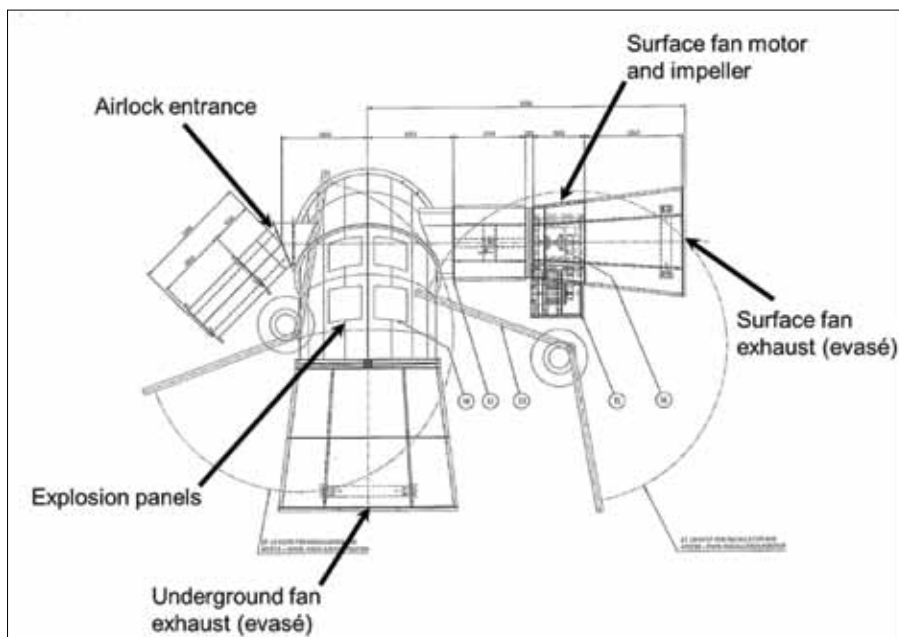
**Figure 8.6: Surface fan as installed<sup>68</sup>**

51. Fläkt Woods designed, built and installed the surface fan. It was powered by a 132kW electric motor with a capacity of 90m<sup>3</sup>/s air flow at 0.4kPa (kilopascals) pressure.<sup>66</sup> The fan acted as the primary fan until the first main fan was commissioned underground.
52. The diagram below shows a bird's-eye view of the surface fan as installed. In the centre was the main underground fan evasé, designed to direct the air flow horizontally and prevent rain or snow entering the ventilation shaft.<sup>67</sup> The surface fan impeller (blades) and motor were to the right. To the left was an airlock entrance allowing access to the fan housing. Anyone climbing the ladder in the ventilation shaft would also exit through the airlock.

55. The surface fan was powered by electrical cabling that ran from the portal substation up the main drift and then to the surface via the shaft. This was unusual. It meant that if power was tripped to the main fan at the portal, for example because of methane in excess of 0.25% in the vicinity of the fan motor, power would also be unavailable to the surface fan. Accordingly, diesel generators were installed to start automatically if the main fan stopped, enabling the surface fan to operate.<sup>70</sup>

56. On the evening of 5 October 2010, about three weeks before the commissioning of the underground fan, the surface fan failed after a blade sheared off.<sup>71</sup> Methane levels rose, power tripped to the underground workings and all personnel underground were evacuated from the mine. The mine gassed out, and on 6 October drops in barometric pressure and temperature caused methane levels in pit bottom to rise to such a level that Pike was unable to send a Mines Rescue Service (MRS) team underground to degas.<sup>72</sup> The daily volume of methane make peaked at 102,000m<sup>3</sup> during degassing on 7 October.<sup>73</sup> Pike conducted a risk assessment together with MRS personnel,<sup>74</sup> and repaired and ran the surface fan using the damper door to 'gradually introduce ventilation underground diluting the gas levels until normal historical gas levels were reached'.<sup>75</sup>

57. A similar event had occurred in July 2009 due to vibration.<sup>76</sup> Project manager Terence Moynihan believed that changes to underground ventilation and surface conditions meant the fan sometimes operated within the stall zone, leading to high levels of vibration and causing fan blade failure.<sup>77</sup> Given the changes from the original

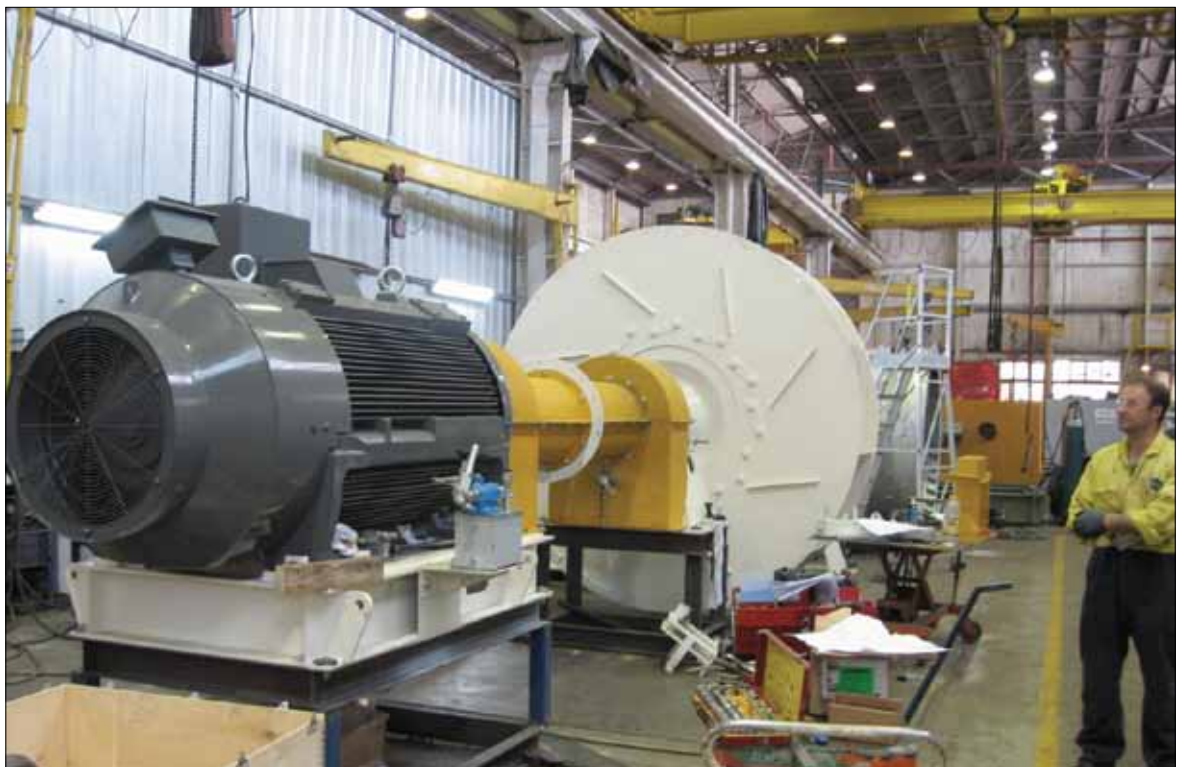
**Figure 8.8: Underground fan being assembled in factory**

60. Pike's first main underground fan was installed in August and September 2010. Its size and configuration are shown in the photograph below. The fan motor (grey) is in the foreground, with the drive shaft (orange) connecting to the fan impeller (white).

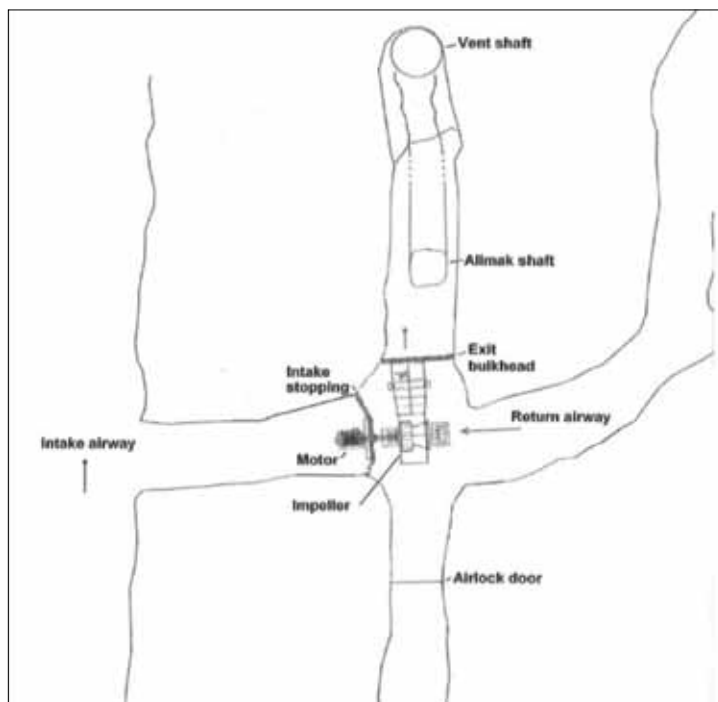
**Figure 8.9: Orientation and operation of underground fan**

62. Air entered from the return airway to the right of the diagram, then passed through the impeller and up the Alimak shaft. The non-flameproof motor was in fresh air on the intake side and sealed off from the fan impeller by a stopping, through which the drive shaft passed. The exit bulkhead was partly fitted with louvres, which were closed when the fan was working, but opened when it tripped. This enabled the surface fan to draw air more easily up the ventilation shaft to maintain mine ventilation. The airlock doors prevented return air from entering the mine intake system.

65. The main fan was first operated on 4 October 2010, but sparks came from the fan shaft at the junction with the intake stopping through which it passed.<sup>85</sup> To resolve the problem Pike removed a brass bush, which formed a seal between the drive shaft and the stopping.<sup>86</sup> This left a gap which Mr Sanders estimated was at least 20mm.<sup>87</sup> Mr White accepted there was potential for methane-contaminated air to leak through the gap if the fan was not operating.<sup>88</sup>

66. Further testing continued and on 22 October 2010 the underground main fan came online and the surface fan switched to standby duty.<sup>89</sup> Almost immediately the main fan suffered problems associated with the VSD power supply and other issues. At first neither the supplier, Rockwell Automation (NZ) Ltd, nor the installer, iPower Ltd, could identify the problem. In late October Rockwell agreed to replace the liquid-cooled 700L VSD with an air-cooled and larger capacity 700H model.<sup>90</sup> Problems continued as the new model was installed in the same VSD cabinet but had a different thermal requirement, and to avoid rising temperatures tripping the power, the mine installed ducting to direct air over the VSD. An air conditioning unit was also ordered, but had not arrived at the time of the explosion.<sup>91</sup>
