# Part 1

+ What happened at Pike River

# Friday afternoon, 19 November 2010

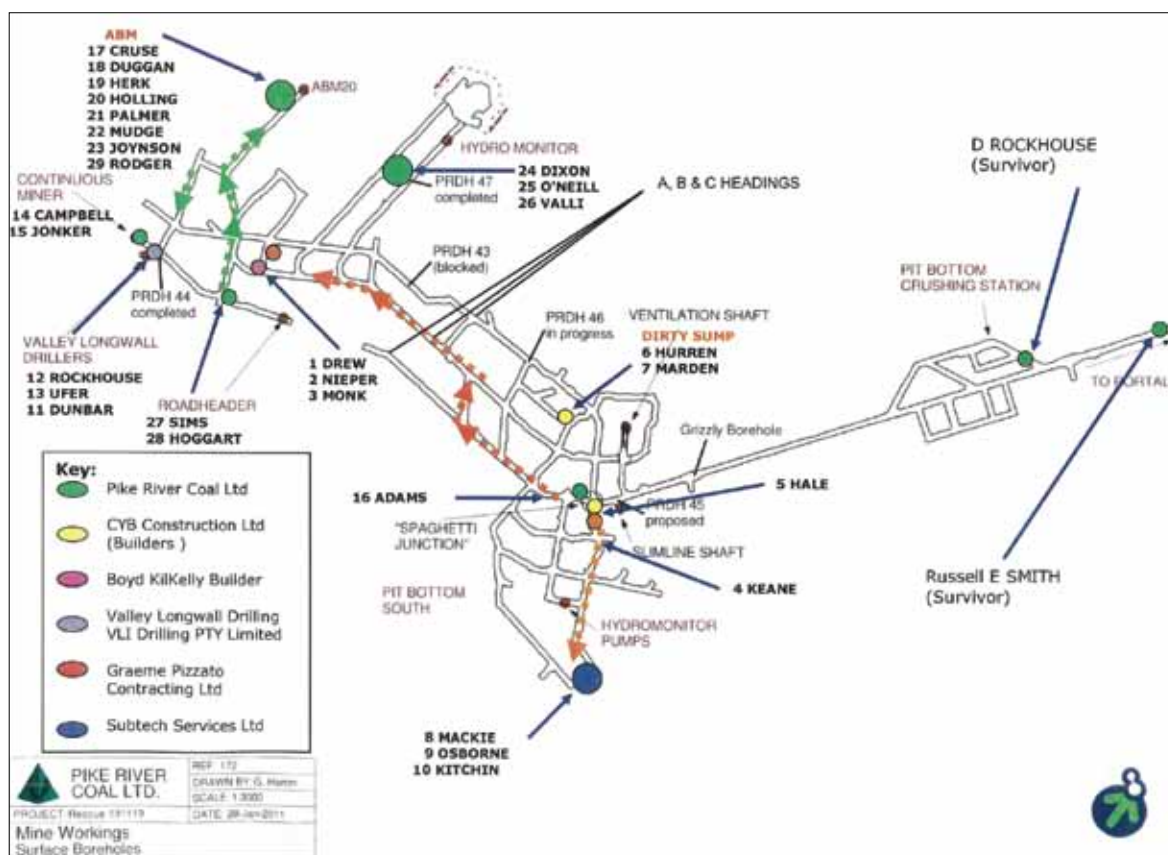
Figure 1.1: Last known position of the 29 deceased and two survivors<sup>2</sup>

6. The positions can only be indicative. They were fixed from the last sightings of the men by people who were also underground but left before the explosion, and also by reference to the work the men were to undertake that day.

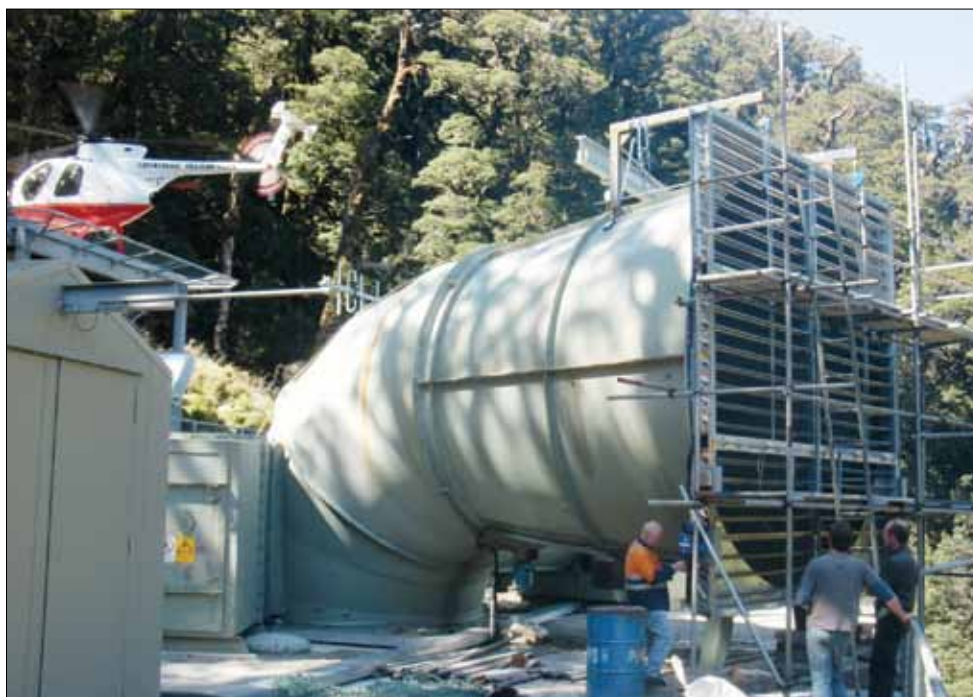
**Figure 8.7: Evasé showing louvres being installed**

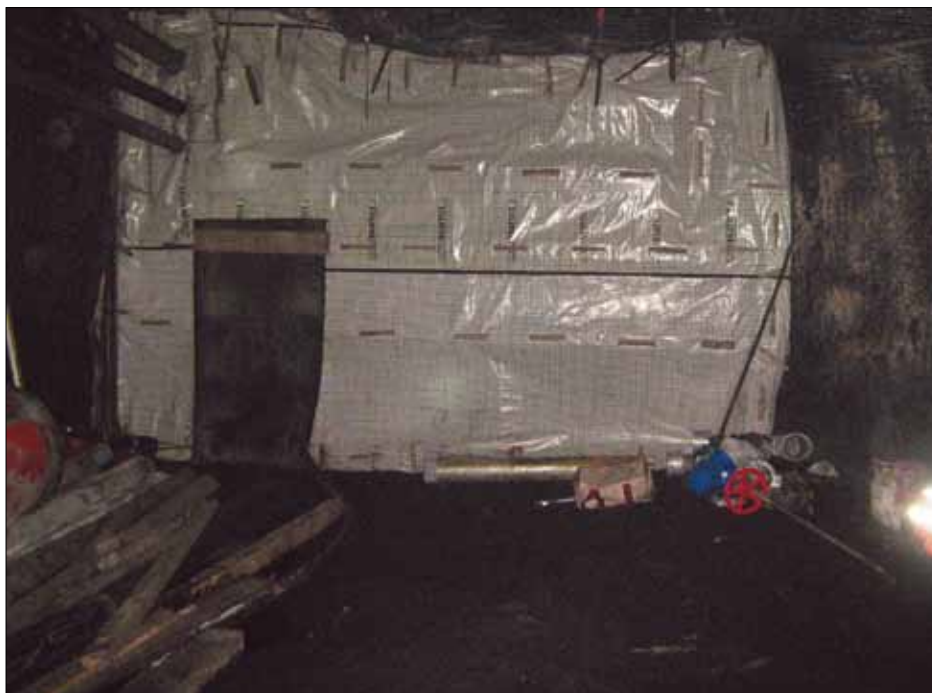
**Figure 8.12: Board and brattice stopping**<sup>148</sup>

104. Stoppings must be constructed to a suitable standard to avoid leakage, which can compromise the performance of the ventilation system. Stoppings should also be built to withstand the pressures that may follow a roof fall or windblast within the mine.<sup>149</sup>

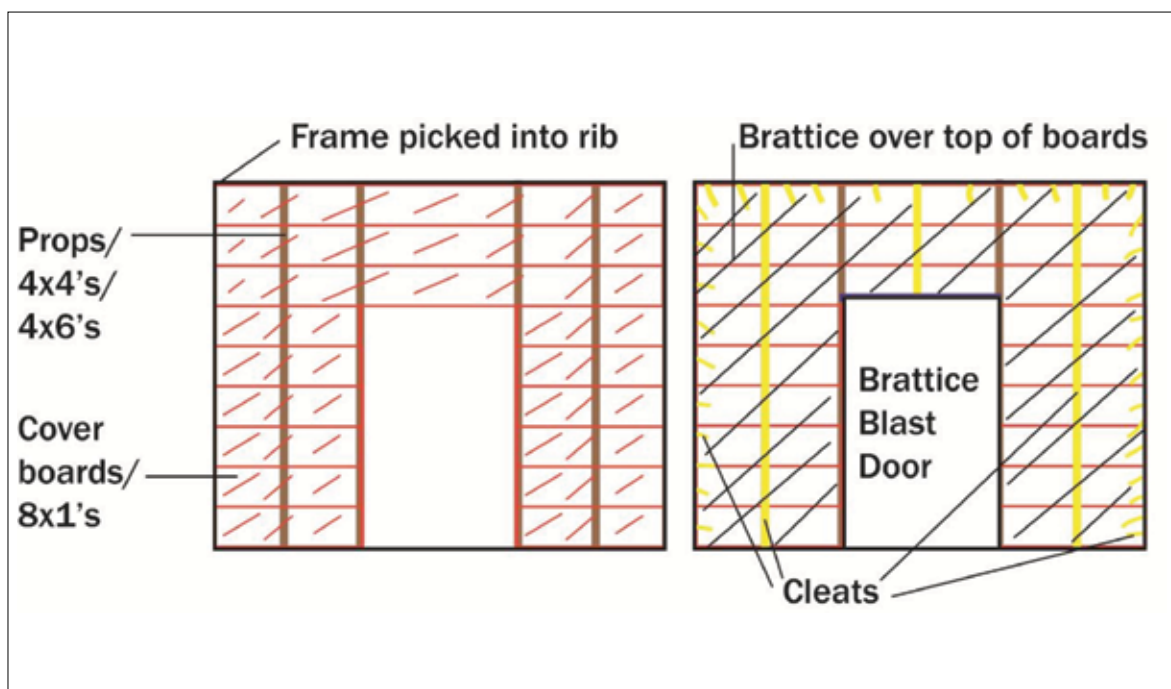
Figure 8.13: Board and brattice construction method<sup>162</sup>

113. In May 2010 Pike issued a standard operating procedure document entitled 'Underground Standards', which set out the standard for both temporary and permanent stoppings.<sup>161</sup> The basic construction method was the same for both, namely board and brattice construction, as depicted in the diagram below and in Figure 8.12.

114. The construction method was essentially to use standard timber covered by brattice. The main difference with permanent stoppings was that these were covered in mesh and sprayed with shotcrete (this is concrete or mortar

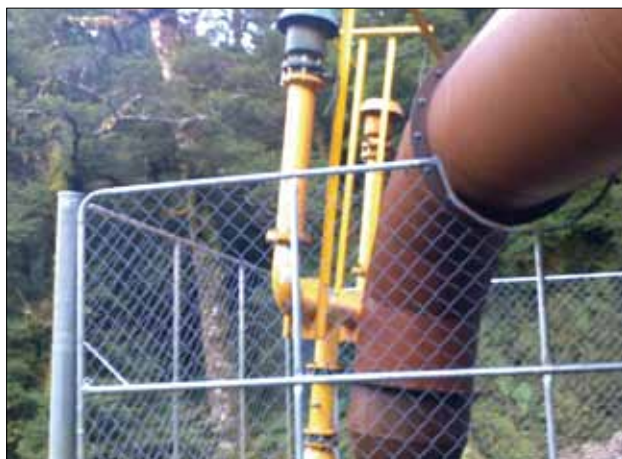
**Figure 9.4: Gas riser and slimline shaft<sup>45</sup>**

53. The collapse of the ventilation shaft on 2 February 2009 severely limited mine ventilation. To recover air capacity, Pike drilled the slimline shaft from the same surface drill pad location it had recently used to install the gas drainage system. Figure 9.4 below shows the gas riser (yellow) with flame arrestors, and the brown pipe is connected to the top of the slimline fresh air shaft.

55. To drill the slimline shaft the flame arrestors at the surface had to be disassembled and removed and the gas drainage line temporarily decommissioned, which resulted in suspension of the drilling programme. VLI's crews left Pike and returned to Australia.
56. The three active boreholes were temporarily closed at the collar, and boreholes GBH001 and GBH002 were soon intersected by development and became inactive for gas flow monitoring.<sup>47</sup>

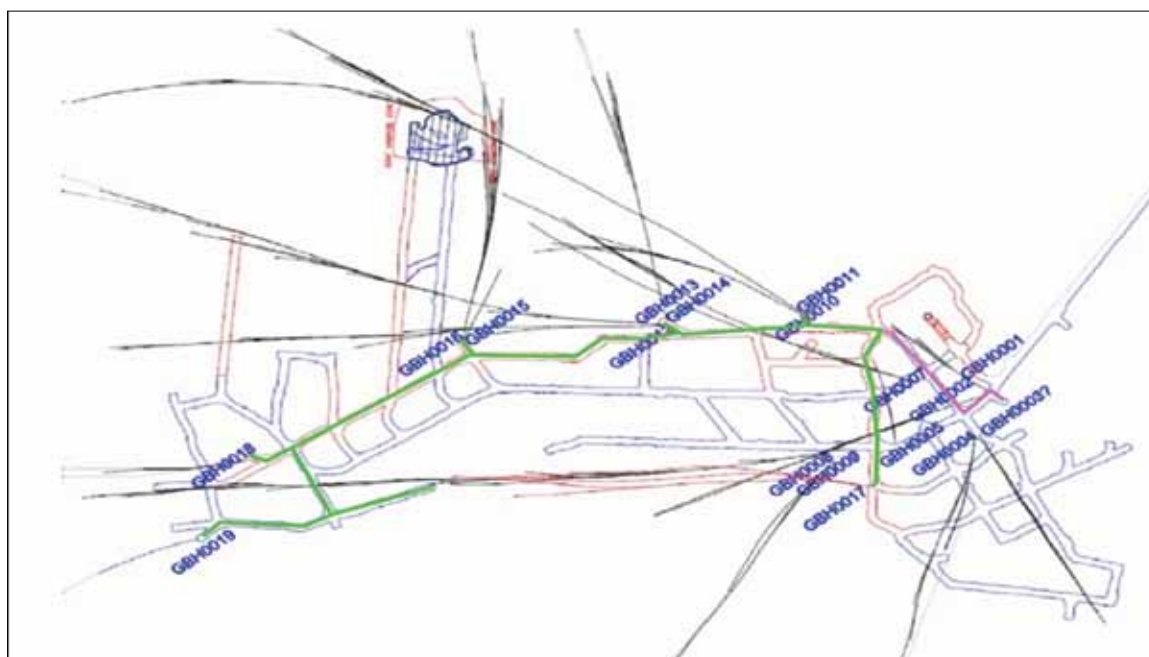
Figure 9.7: Gas drainage line and in-seam boreholes<sup>67</sup>

70. The pipeline was installed primarily in the return airways leading from connected boreholes outbye to the riser (as shown below in green), but it also ran for about 100m in the intake airway (shown in pink) from the overcast near the underground fan through Spaghetti Junction before turning left and then right to the gas riser located at the entrance to the slimline shaft/FAB. This created a significant hazard.

71. During a risk assessment into the operation of the ventilation fans held on 14 October 2010, an action plan recorded the need to move the methane drainage lines into a better area, away from the methane sensor at the main fan motor.<sup>68</sup> This had not occurred by 19 November 2010.
72. Staff from the technical services department disagreed with the decision to establish an FAB near the gas drainage line and riser, but the design decision was not theirs.<sup>69</sup> Mr Reece also criticised the decision:

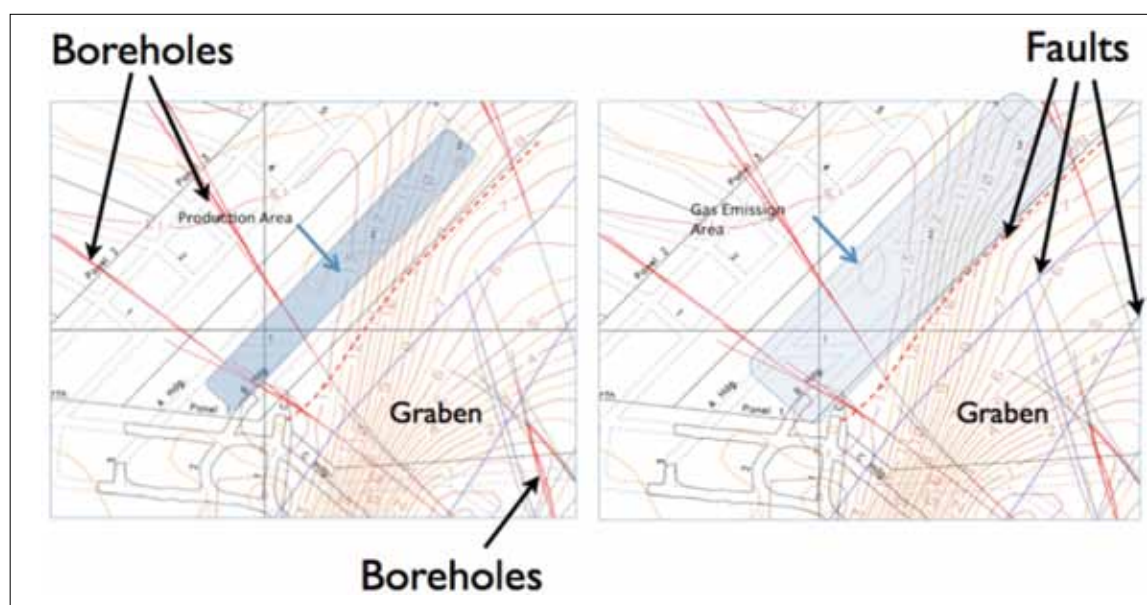
Figure 9.8: Panel 1 production area and panel 1 area of interest for gas emissions<sup>129</sup>

109. The following diagrams show the proposed production area of the hydro panel, and the expected gas emission area for gas flows from the surrounding strata.<sup>127</sup> Long in-seam boreholes intersect the panel,<sup>128</sup> and faulting to the east of the panel is shown.

110. Borehole GBH016 was subsequently drilled 'flanking' the eastern boundary of panel 1, but no drainage holes were drilled within or to the west of the panel. GBH016 and the intersected boreholes were designed primarily for exploration of the seam, not for systematic pre-drainage of methane from the panel before mining.<sup>130</sup>
111. The gas content core sample result of 8.29m<sup>3</sup>/t from GBH016 underlined the need for further drainage of the area, particularly given the use of an untried hydro-extraction method in a thick seam with the likelihood of high methane release. However, coal extraction from panel 1 began without pre-draining the seam down to safer gas levels.

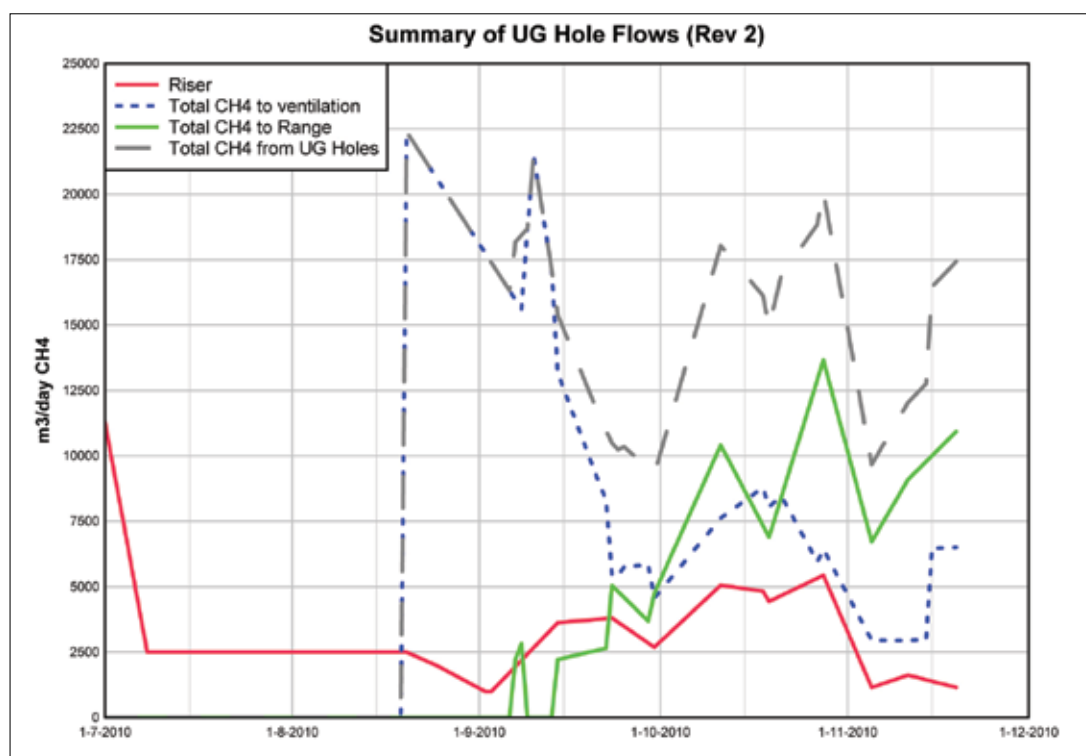
Figure 9.9: Graph summarising total daily drainage system gas flow measurements<sup>150</sup>

126. The following graph prepared by the joint investigation expert panel<sup>149</sup> summarises the total daily methane volumes ( $\text{m}^3/\text{day}$ ) for the drainage system gas from July 2010 until the explosion. The red line depicts the volume of methane measured at the bottom of the gas riser, which decreases from the beginning of July when the practice of free venting began with GBH012 disconnected from the range. The blue line shows the volume of methane free vented to the mine's atmosphere for dilution by ventilation; and the grey line shows the total methane flow from all boreholes. These measurements began on 20 August 2010, the start of gas flow measurement from individual boreholes. The green line shows the total methane volume flowing into the range from September 2010 when weekly gas drainage measurements commenced.

127. The noteworthy features are the high volume of methane free vented when compared to the volume of gas entering the range, and the difference between the volumes entering the range and reaching the bottom of the riser. For example, on the day of the explosion the measured gas flow into the range was 126.4 l/s but only 13.3 l/s was measured at the gas riser. Such discrepancies dated back to the beginning of October. Various explanations for the difference have been suggested including leakage, methane back-feeding into other areas, a blockage in the range or incorrect measurements at the gas riser.<sup>151</sup>

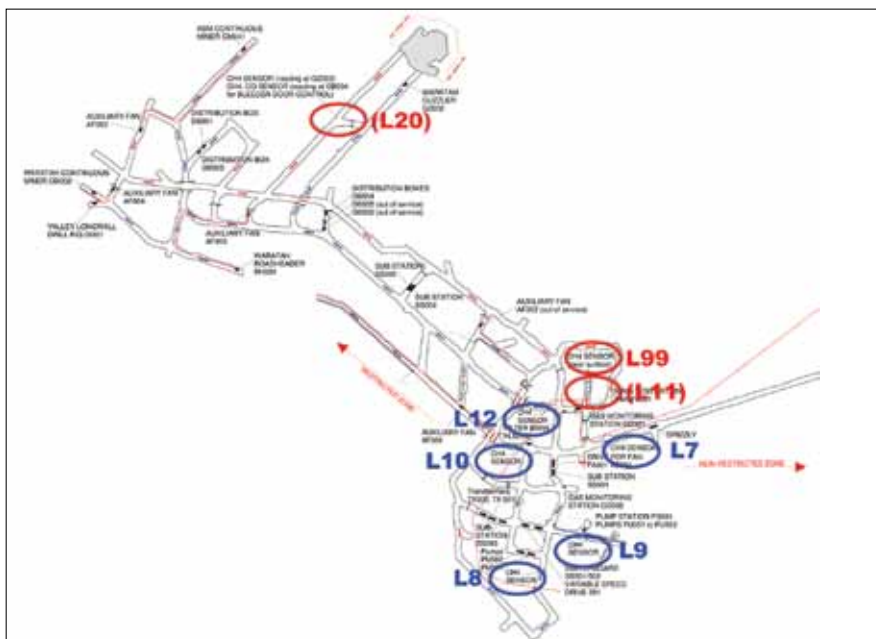
Figure 10.1: Location of fixed methane sensors<sup>22</sup>

11. As at 19 November 2010 there were eight fixed methane sensors connected to the surface control room,<sup>21</sup> shown in Figure 10.1.

12. The five sensors circled in blue were all located within the intake roadways, in areas expected to be ventilated by fresh air. These sensors were located at or near electrical equipment in an area Pike designated as the 'non-restricted zone'. Regulations require the non-restricted zone to contain no more than 0.25% flammable gas. The sensors in this area at Pike River were set to trip power at 0.25% methane.

14. The sensor at L11 stopped working on 4 September 2010,<sup>24</sup> and the sensor at L20 stopped working on 13 October 2010,<sup>25</sup> leaving Pike with no gas sensors reporting to the surface from further into the return than the ventilation shaft. This did not give the mine adequate information about the location, source and quantities of flammable gas within the mine. Surface controller Barry McIntosh said the controllers had raised the issue of the location of gas sensors, and in his view the gas sensors 'weren't up far enough' in the mine.<sup>26</sup>

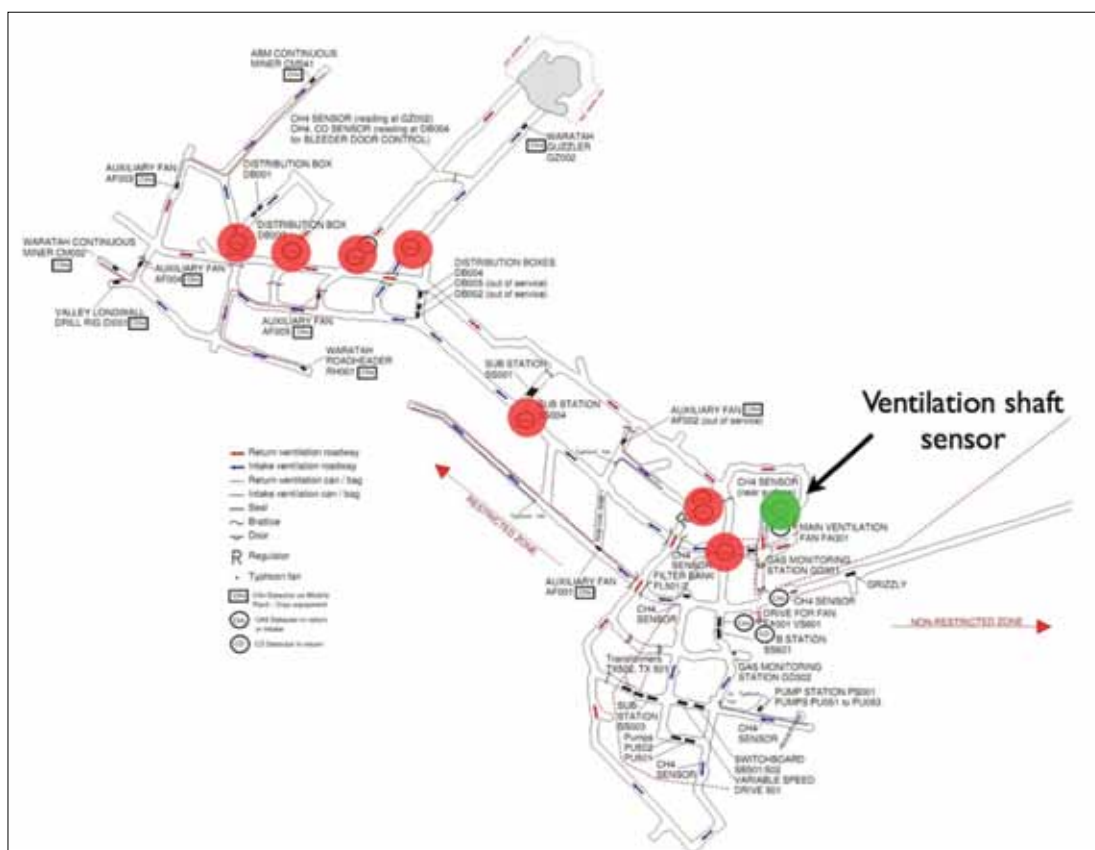
**Figure 10.2: Plan of required gas sensors at Pike River under Queensland legislation<sup>27</sup>**

15. By way of comparison, consultant David Reece provided on request a plan showing where Pike would have typically required gas sensors under Queensland legislation. His plan was not absolute and was subject to a number of technical qualifications including the proximity of other detectors, but on the basis of the plan, Pike would probably have required seven fixed sensors (marked in red) reporting to the surface from inbye of the ventilation shaft. As at 19 November Pike did not have any fixed gas sensors reporting to the surface in these areas. The only functioning sensor reporting to the surface from the return was at the position marked in green on the plan.

16. The joint investigation expert panel said that the mine 'should not have operated' without at least two sensors in the return, connected to an alarm and set to trip the power supply for the underground fan.<sup>28</sup>

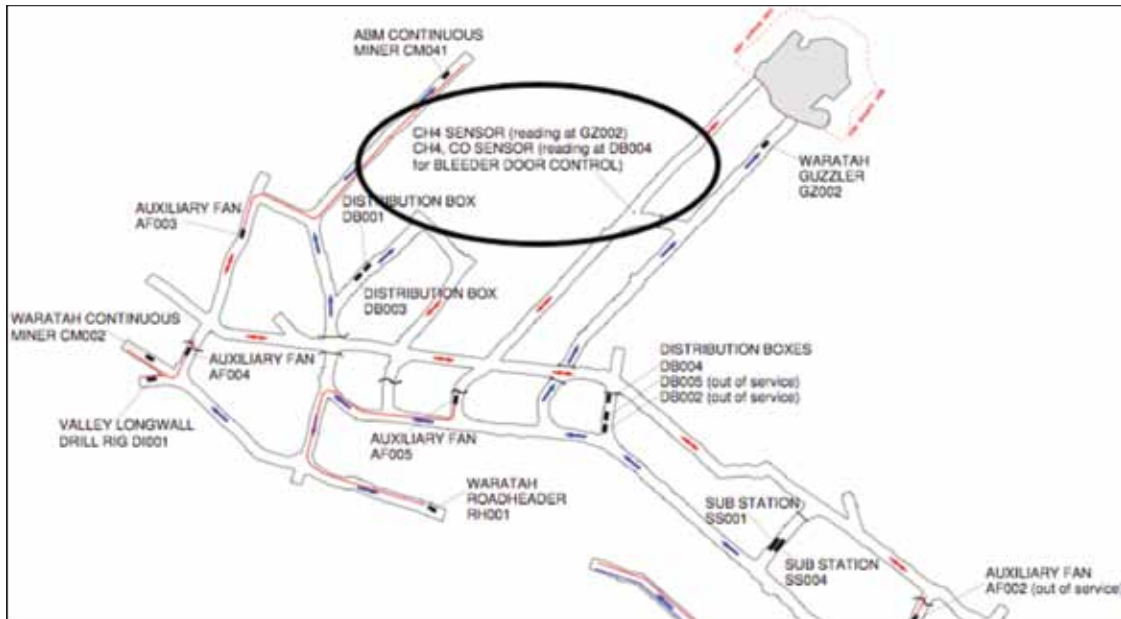
Figure 10.3: Location of hydro-panel sensors<sup>29</sup>

17. There were two methane sensors located in the return from the hydro panel, circled in black on the diagram below.

18. One provided a reading at the guzzler near the hydro monitor, but did not report to the surface or result in any permanent record of gas levels. The other sensor had been exposed to methane concentrations above 5%, and did not work after 13 October 2010.<sup>30</sup>

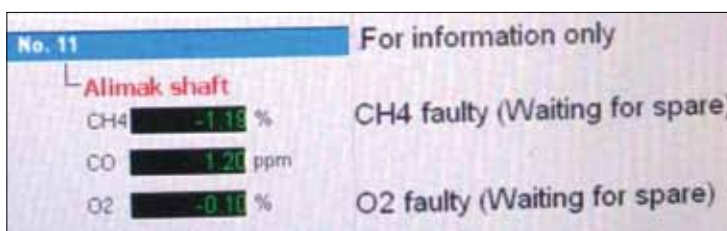
Figure 10.4: Control room operator's screen on the Safegas system<sup>32</sup>

19. There were several problems with the gas sensors in the ventilation shaft. First, the sensor at the bottom of the ventilation shaft stopped working on 4 September 2010, nearly 11 weeks before the explosion, and was never repaired or replaced.<sup>31</sup> Indeed, the control room operator's screen on the Safegas system was permanently annotated to say the sensor was 'faulty' and 'waiting for spare'.

20. Mr White was not aware the sensor was not working and could not explain why the sensor was broken for two and a half months without his knowledge.<sup>33</sup> The problem appears to have been discussed at the review of the surface fan failure on 7 October 2010, at which Mr White was present.<sup>34</sup> It was resolved to 'Set up Gas Monitoring [at] shaft bottom',<sup>35</sup> but was still to be done at the time of the explosion.

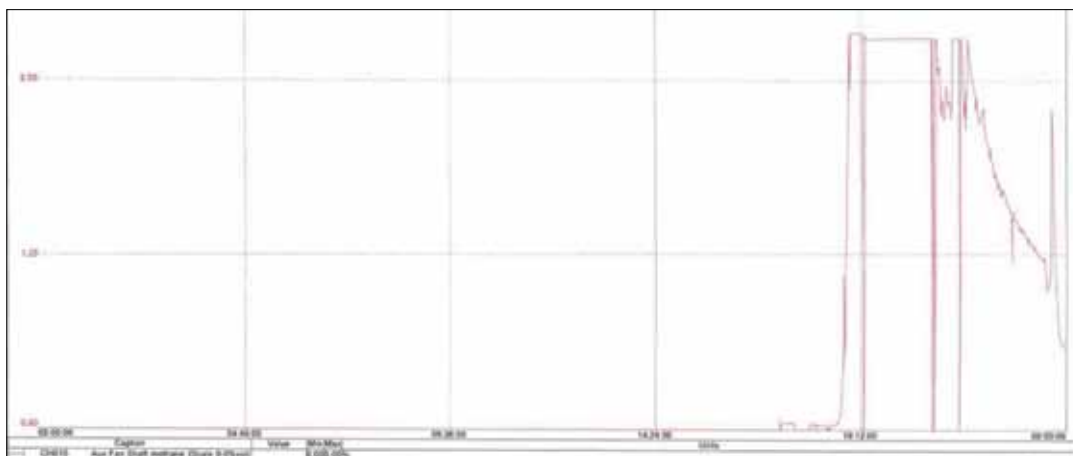
Figure 10.5: Auxiliary fan shaft methane – 6 October 2010<sup>43</sup>

24. The ventilation shaft sensor also 'latched' or was poisoned on a number of occasions, causing a flat line to show on the surface controller's system. The flat line phenomenon indicated the sensor had been exposed to greater than 5% methane. This occurred during the 'gassing out' of the mine on Wednesday 6 October 2010, after the failure of the surface fan.

25. There was no data from the sensor from the time of the fan failure on 5 October. The control room system then showed a flat line around 2.5% during the evening of 6 October. Despite a review and a notification to the Department of Labour (DOL) about the incident, nothing was done about the flat line issue.
26. There was then a second flat line that started late on Thursday 7 October and continued through to Friday 8 October 2010 during the degassing procedures.

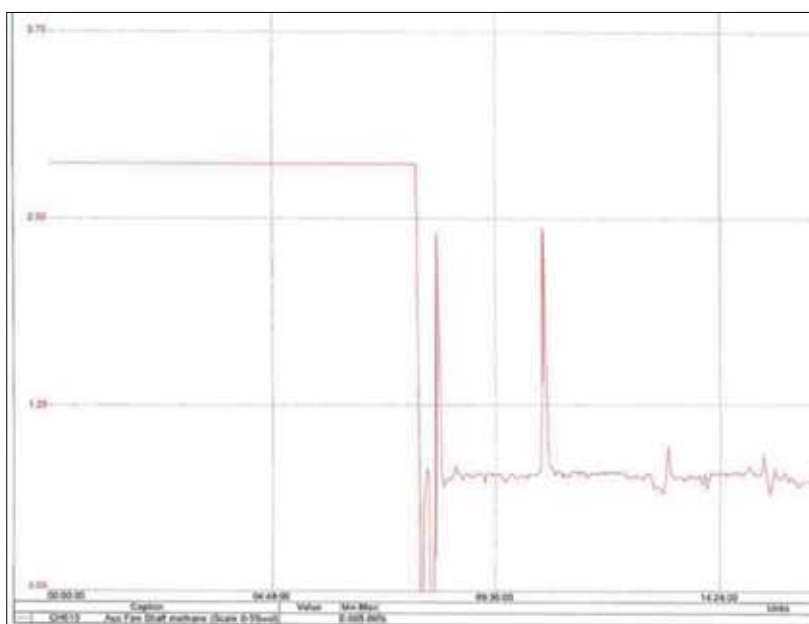
Figure 10.6: Auxiliary fan shaft methane – 8 October 2010<sup>44</sup>

27. Mr White told the commission he was not aware of any flat lines, and if he had been, it would have been a cause for investigation.<sup>45</sup> However, he accepted that he signed a ventilation survey dated 7 October 2010 that said in red capital letters 'Had a spike of 2.8% at vent shaft – monitor stuck on this reading.'<sup>46</sup>
28. Third, while the sensor at the bottom of the shaft was operational, there was an obvious discrepancy between the readings at the top and bottom of the shaft. The discrepancy is shown in the following graph prepared by DOL, which shows the reading from the top of the shaft in red, and the reading from the bottom of the shaft in blue.

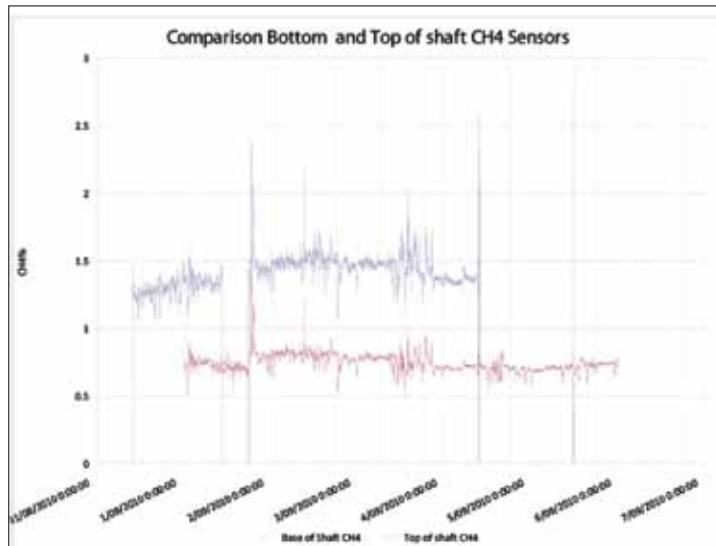
**Figure 10.7: Comparison bottom and top of shaft CH<sub>4</sub> sensors<sup>47</sup>**

29. There was an obvious question to be answered given that two sensors in the same air stream were reading so differently.<sup>48</sup> The discrepancy was not investigated.<sup>49</sup>

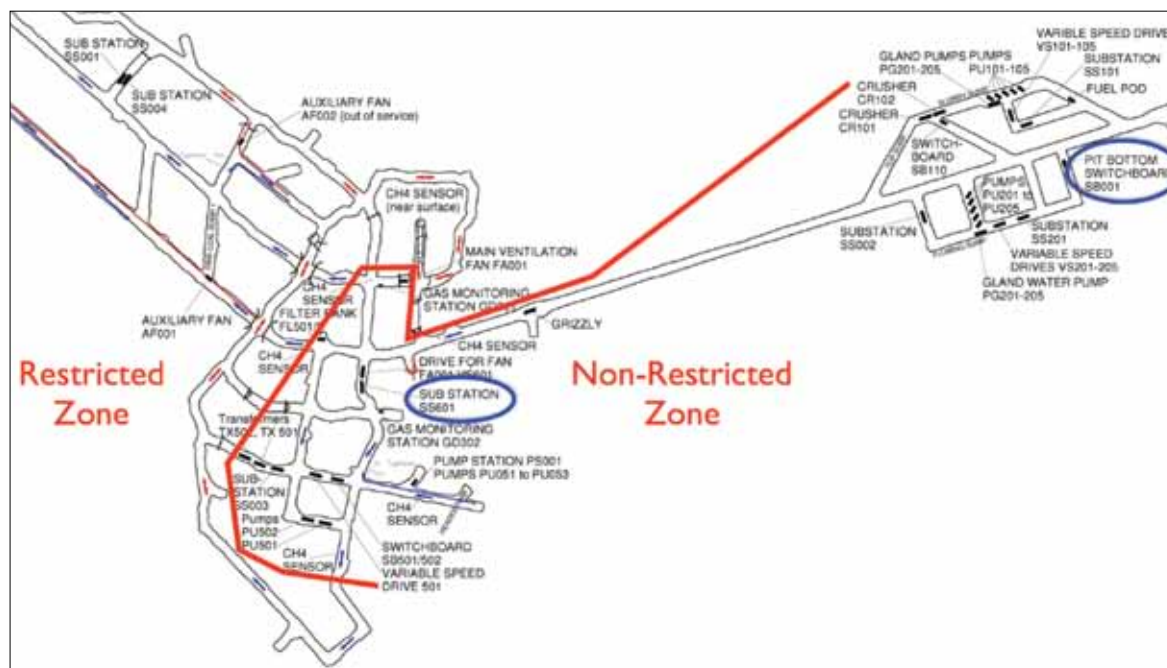
Figure 11.1: Main electrical area and zones underground<sup>2</sup>

9. The red line in Figure 11.1 marks the boundary between two underground zones, the restricted zone, which is to the left of the line and includes the coal workings, and the non-restricted zone to the right. That non-restricted zone includes Spaghetti Junction and much of pit bottom south. The zones are explained below.

19. A stopping failure or ventilation fan failure (which may be followed by the reversal of ventilation) could result in methane being introduced into the pit bottom south non-restricted zone.<sup>13</sup> Because some equipment in that zone was not intrinsically safe or flameproof, methane sensors and the associated safety cutouts had to be relied on if methane entered the area.

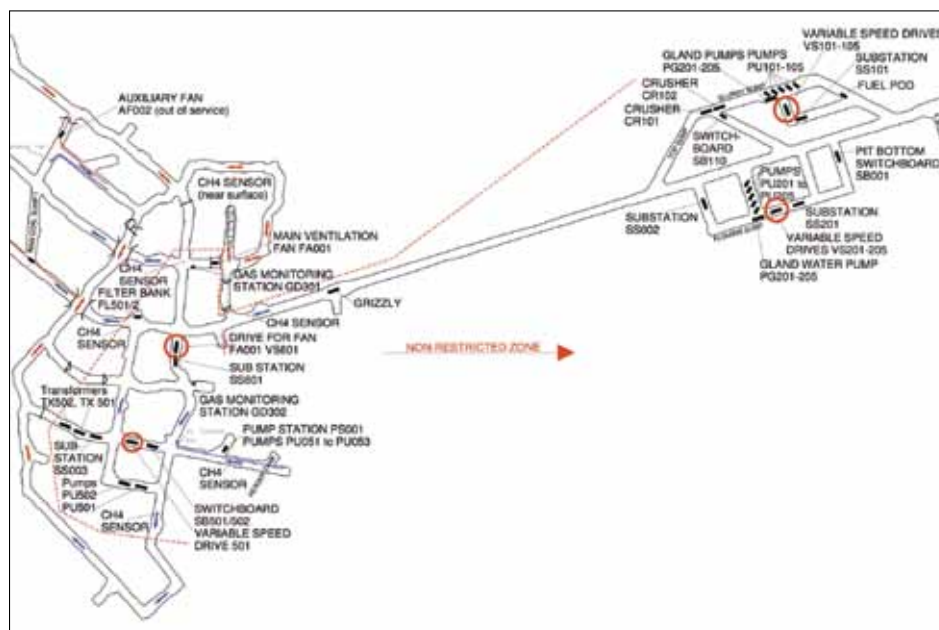
Figure 11.3: Plan showing VSDs underground at Pike River<sup>22</sup>

He had never seen a configuration such as that at Pike River, which was essentially a significant number of fixed VSDs underground.

32. VSDs have the potential to cause enough harmonic distortion to generate sparking within the earth system of the power supply. The extent to which harmonics occur depends on many matters, including the type of VSD, the manner in which it is installed and the cabling type, length and connection. The installation and cabling details at Pike River remain unclear.<sup>25</sup> There is conflicting evidence from Mr Reczek and Rockwell, the supplier of VSDs, about the extent and effect of harmonics. This is referred to in more detail in Chapter 14, 'The likely cause of the explosions'.

33. There were other problems associated with the use of VSDs. There was an overvoltage in the power supply to at least one VSD, affecting its performance; this was rectified on about 9 November 2010. Five VSDs failed and were removed. In one case a power structure exploded. On several occasions pre-charge resistors failed. This problem was to be solved by changing the ratings of protective fuses. New fuses had been ordered but not replaced by the time of the explosion.

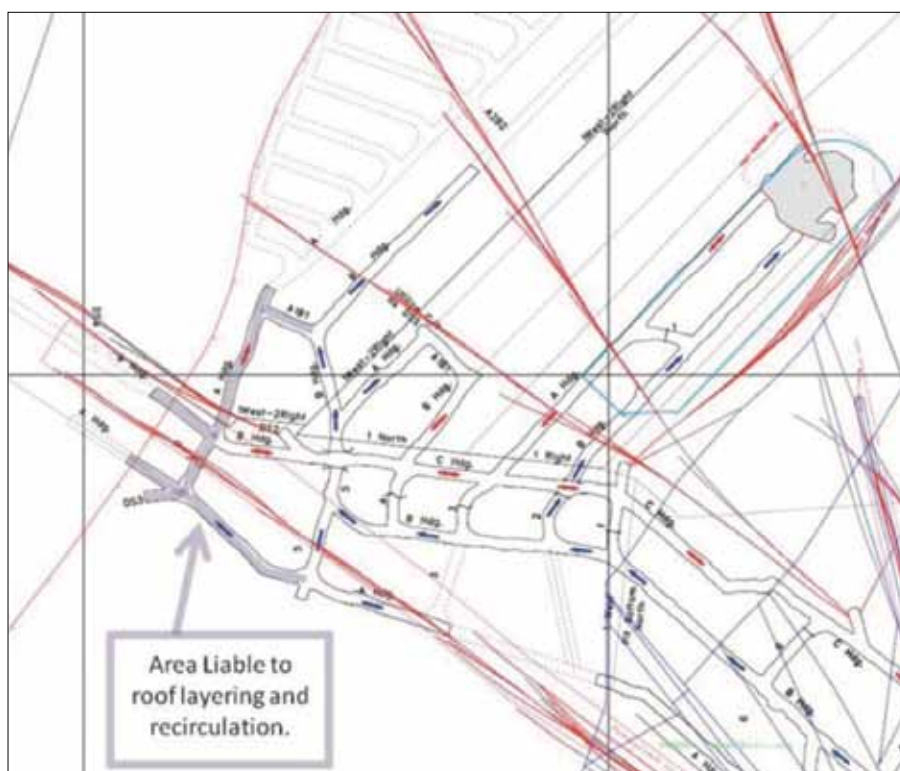
Figure 14.2: The area of the goaf and the intersecting borehole<sup>15</sup>

33. The expert panel concluded that there were few potential locations within the mine capable of producing the required volume of methane. One possible location was the hydro panel goaf.
34. Hydro mining at Pike River had created an irregular goaf approximately 30m wide, 40m deep and up to 9m high. The void volume was approximately 6000m<sup>3</sup>. The goaf was not ventilated. Methane would have continued to bleed from the coal seam into the goaf.<sup>13</sup> It also contained an in-seam borehole drilled to explore the limits of the seam and also pre-drain methane. The borehole had been intersected during hydro mining, and therefore provided an additional potential source of methane.<sup>14</sup> The diagram below illustrates the area of the goaf (top right corner) and the intersecting borehole. The gas drainage lines are marked in red.

There was also a rider seam above the goaf which, after disturbance of the roof strata during mining activity, could leach further methane into the goaf.

42. The third, and 'less likely', scenario was a gas accumulation centred in the most inbye and western area of the mine, where the two continuous miners, the roadheader and the in-seam drilling rig were located. This area is depicted in Figure 14.2 and labelled 'area liable to roof layering and recirculation'. There had previously been ventilation and gas management problems in this area, which triggered the shutdown of machinery and the initiation of various methane control measures. In giving evidence, Mr Reece said scenario three was considered less likely because of the significant volume of methane required, which experienced workers, and statutory officials, should have detected and reacted to.<sup>22</sup>

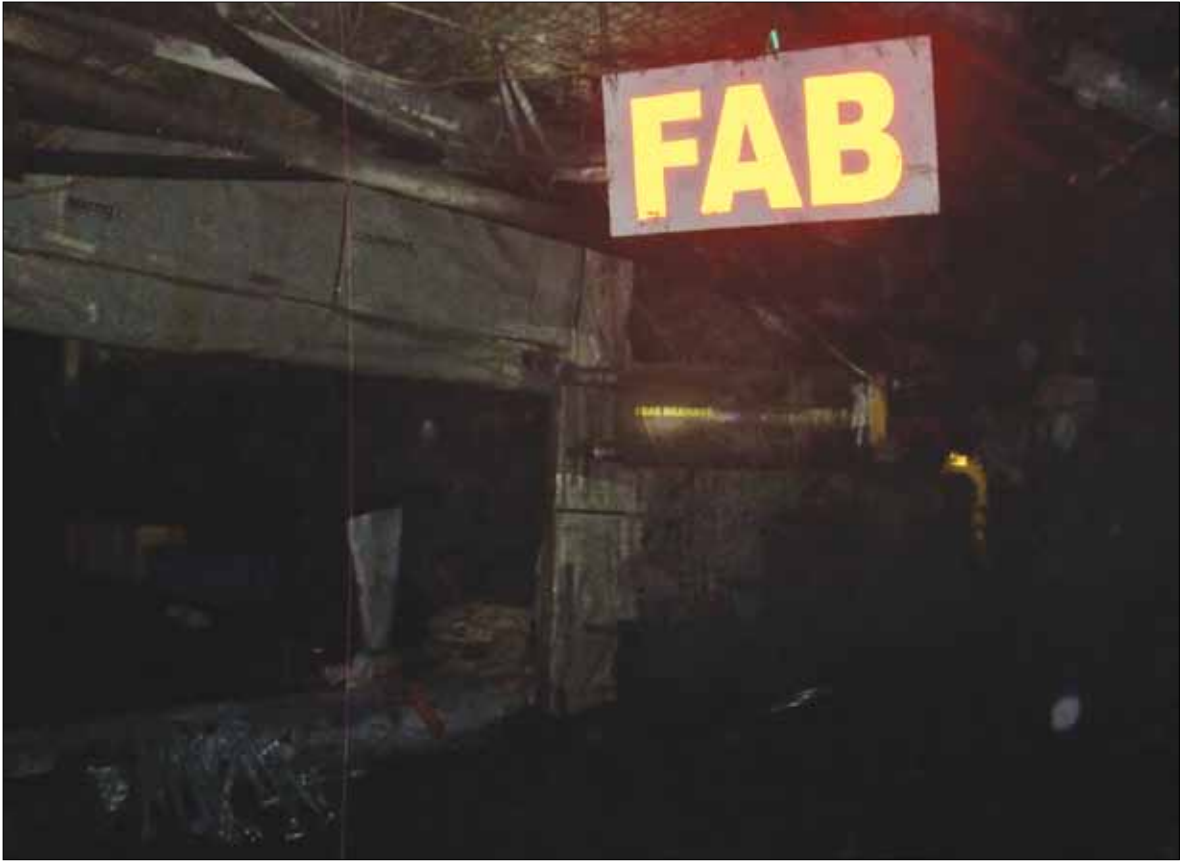
Figure 16.2: View of the upper FAB from outside<sup>78</sup>

132. The upper FAB was developed in March 2010 following a risk assessment which found that the main vent shaft was not suitable as a second means of exit from the mine. The slimline stub was 15m deep, 5m wide and 5m high. The methane drainage line passed through the stub and vented through a gas riser to the surface. A roll-down brattice door was installed so the stub could be isolated in an emergency. Fresh air was available from the surface through the 600mm diameter slimline shaft. The stub contained a cache of 108 self-rescuers (60 of 30 minutes' duration and 48 of 60 minutes' duration), first aid equipment, fire-fighting equipment, a digital access carrier (DAC) and three telephones, one of which was connected to the surface. Pike had planned improvements to the slimline stub, such as increasing its size, installing concrete walls and double doors incorporating an air lock system. The improvements were meant to have been completed by June 2010 but had not been done by the time of the explosion.

133. The roll-down brattice screen would not have prevented the FAB being polluted with the toxic atmosphere. Following the explosion, the failure of the underground fan resulted in a reversal of the air circuit, meaning the slimline shaft became a chimney through which noxious explosion products were drawn into the stub and up to the surface. The upper FAB was not a place of safety and was not functional as an FAB at 19 November 2010. It was not even fit as a changeover station.
